**PORT OF NEWPORT**  
**COMMERCIAL FISHING USERS GROUP COMMITTEE**

**IV. Port Dock 7 Project Update – Bretz**.....Page 12

△	DATE	REVISION	BY	ACCOMPANIED BY DRAWINGS:	<b>PORT OF NEWPORT DOCK 7 REPLACEMENT DESIGN</b>  YAQUINA BAY NEWPORT, OR  <b>TITLE SHEET</b>		5 Centerpoint Drive, Suite 350 Lake Oswego, OR 97035 503.620.6103 WWW.DOWL.COM				
	△							SCALE WARNING  If scale bar does not measure one inch, then drawing is not to scale	DESIGNER: Baelie Werner, EI      REVIEWER: Nick Robertson, PE, SE CHECKER: Jael Wettach-Ogle, PE      DRAFTER: Samantha Stauss	DATE: AUG 2025      STRUCTURE NO.: N/A      CALC. BOOK: N/A      SHEET: 1 OF 11      DRAWING NO.: 1

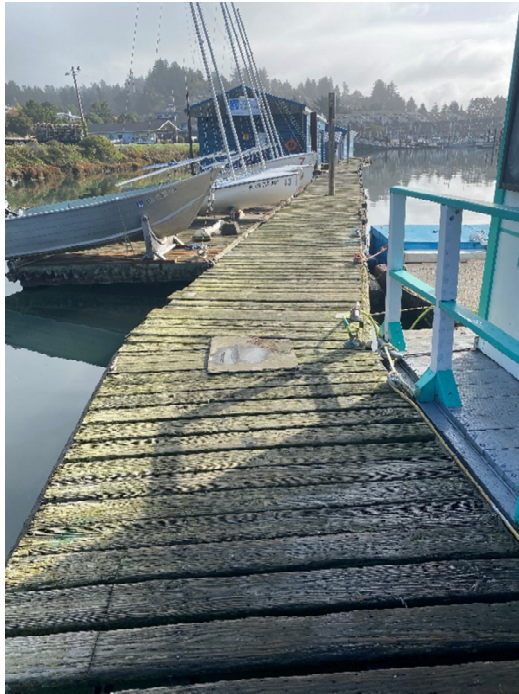
**Photo 1: Overall condition of Dock B.**

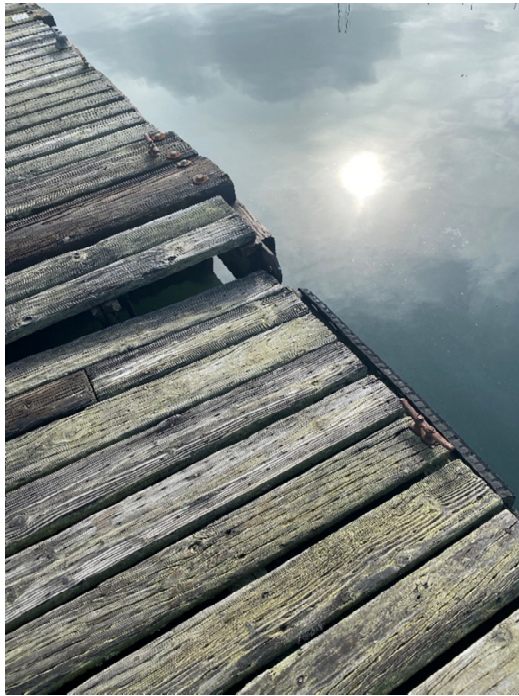
**Photo 2: Missing hardware near space 15 on Dock B**

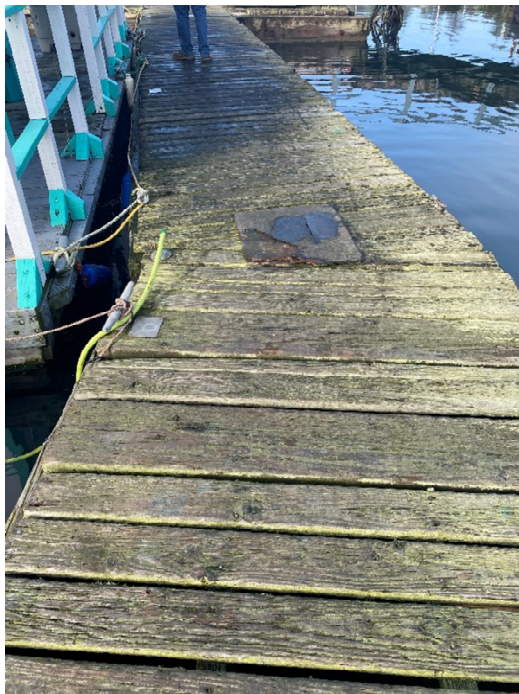
**Photo 3: Hole with decayed patch in Dock B**

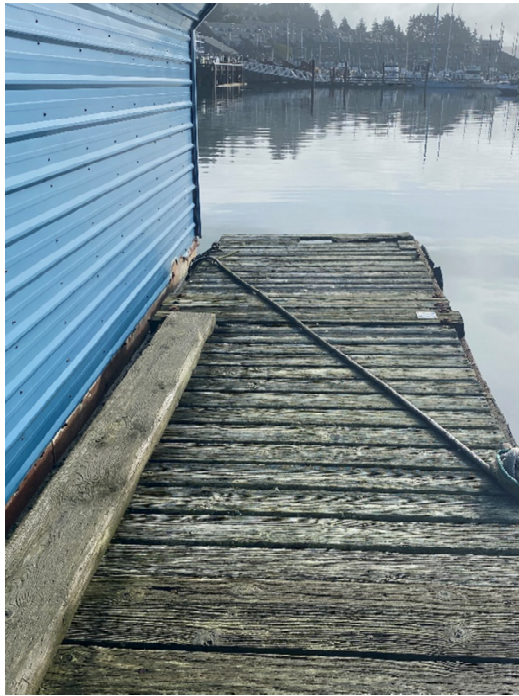
**Photo 4: Supplemental rope restraining Dock B to nearby piling**

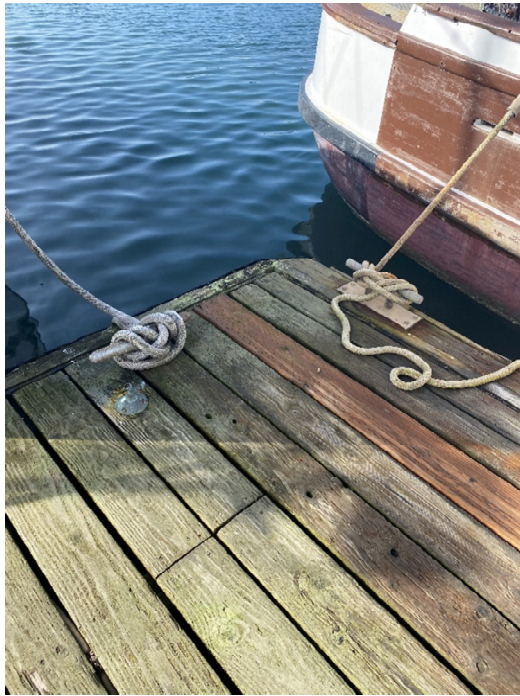
**Photo 8: Typical condition of mooring hardware**

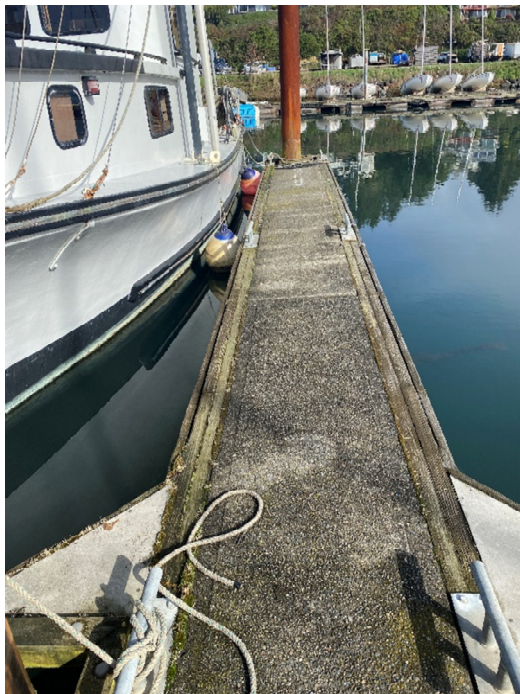
**Photo 9: Concrete finger, showing a lean to one side**

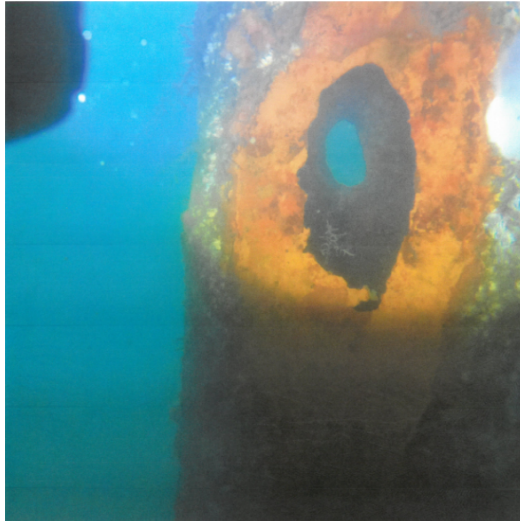
**Photo 10: Corroded pile near slip 25**

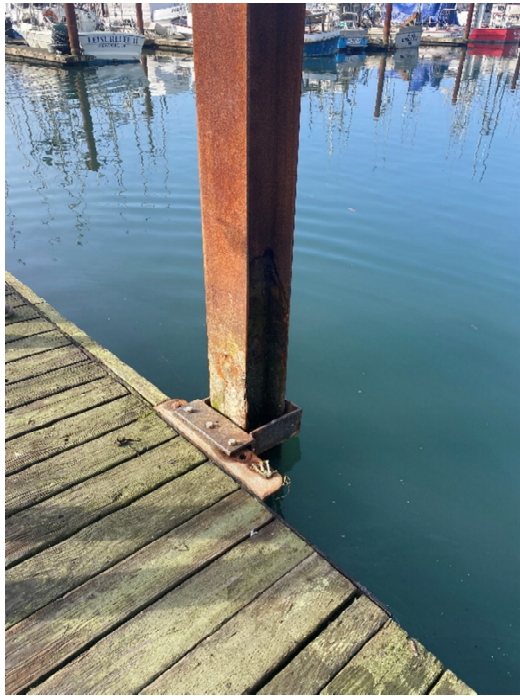
**Photo 14: H Pile on Dock X near the gangway. Note heavy corrosion near the waterline.**

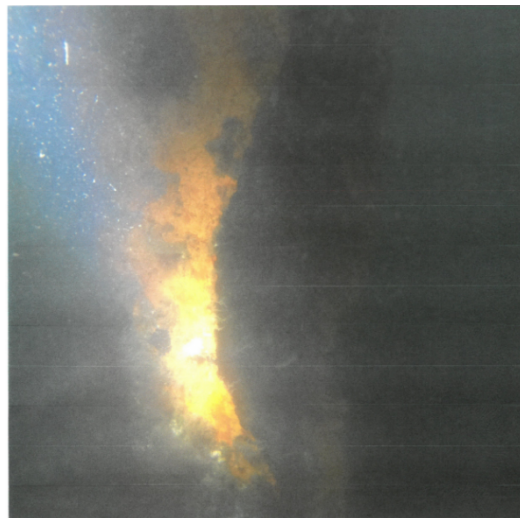
**Photo 15: Typical view of H piles from underwater.**

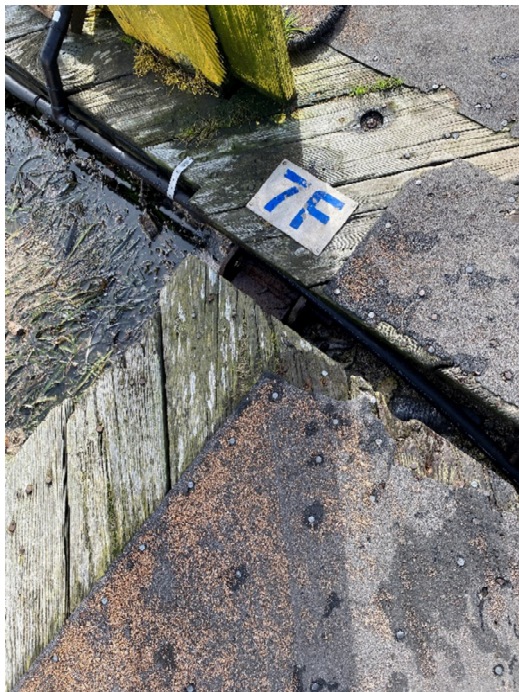
**Photo 17: Missing hardware at intersection of Dock X and Dock E/F**

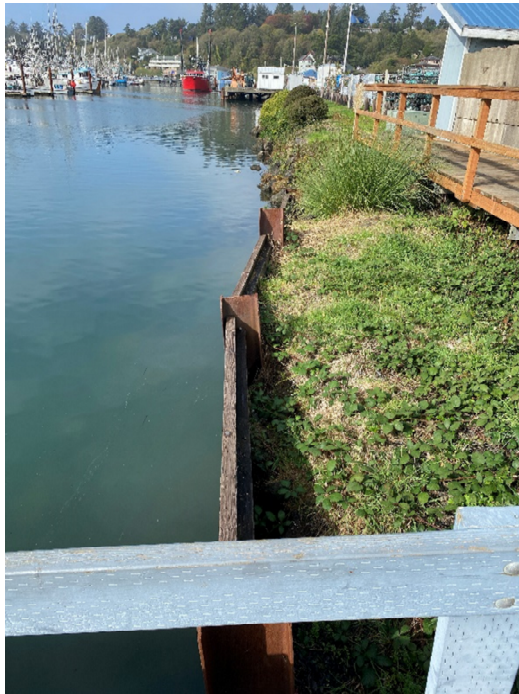
**Photo 18: Leaning bulkhead wall**

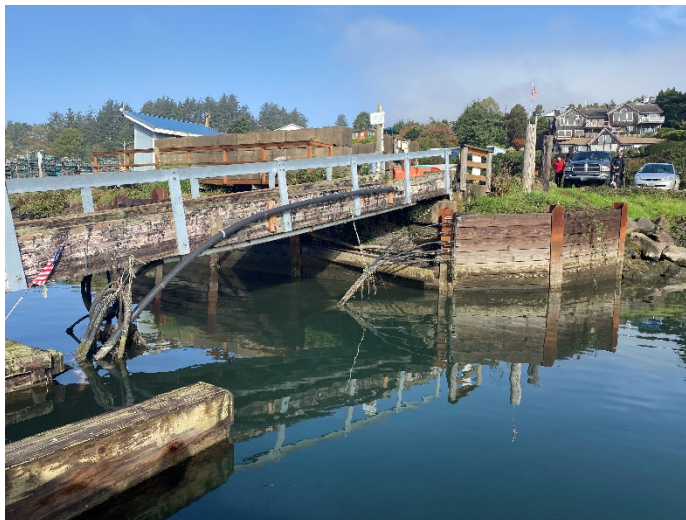
**Photo 19: Fallen utilities on gangway. Also note missing lagging in wall.**

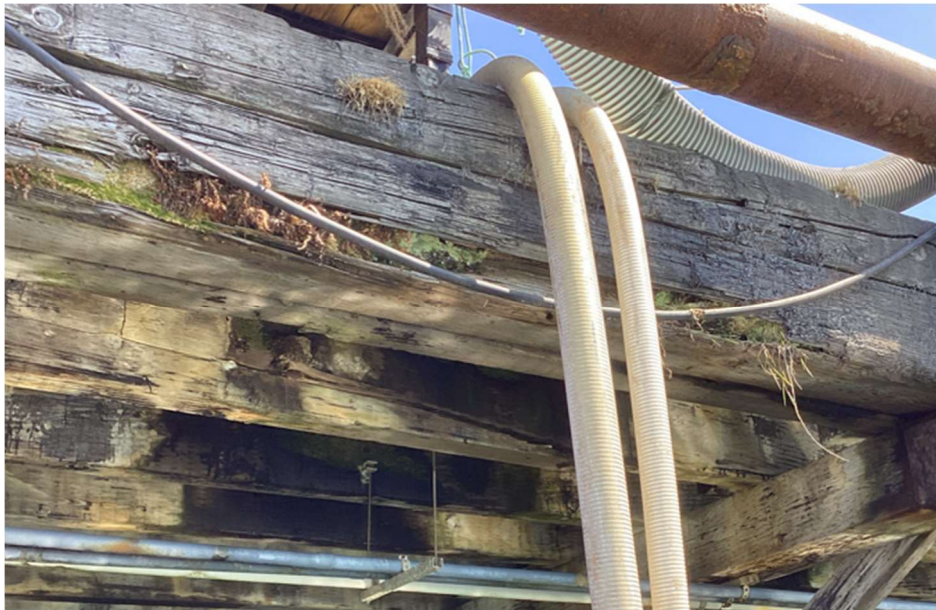
The superstructure is comprised of both timber girders and prestressed concrete slabs. The timber girders run parallel to the shoreline and are spaced at 30-inches on center and are roughly 12.5 feet long. The timber girders were visually inspected as well as sounded for decay. Overall, the timber girders were in fairly good condition. Each member had various degrees of drying checks with heavy water staining and discoloration. There was one timber girder that was found to be broken and was located near the end and centerline of the dock.

Broken Timber Girder

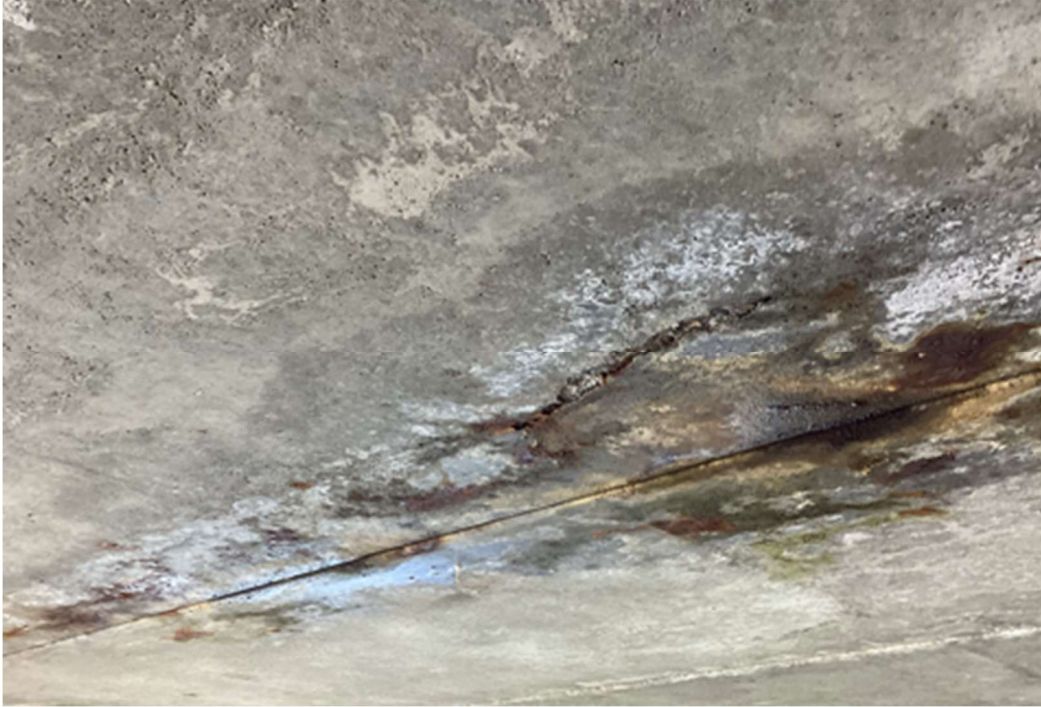
There are forty-two (42) slabs in the newer portion of the dock that run perpendicular to the shoreline (21 slabs on either side of the original structure). The top side of the slabs is covered with AC and not visible during our inspection. The underside soffits were visually inspected and found to have several locations where the concrete was delaminated with evidence of cracking along the edges of the delaminations. There was evidence of rust staining at many of these locations which indicates active corrosion to the reinforcing steel in the slabs. Most of these delaminations were noted in the east structure.

Delamination and Rust Staining in Underside of Slab

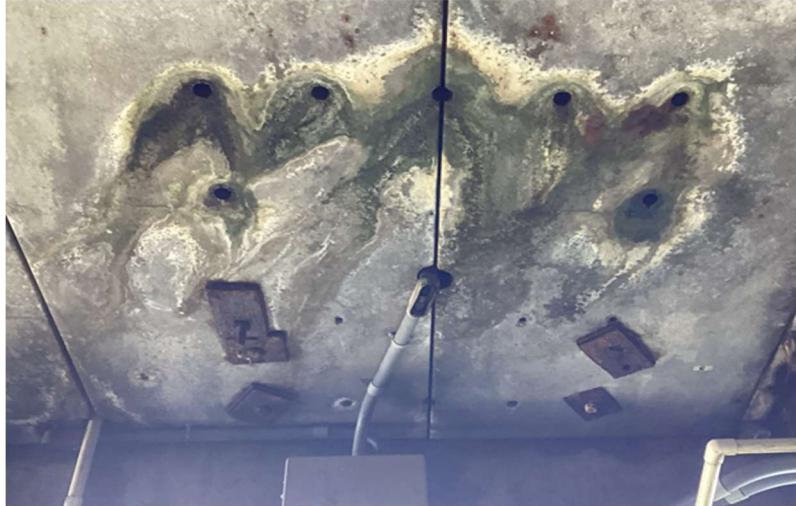
Several girders have bolted connections or holes for the hoisting systems. The hardware was heavily corroded and there was water staining in holes that were not being used. No evidence of corrosion was noted in holes that were not being used.

Holes in Slabs and Hoist Connections

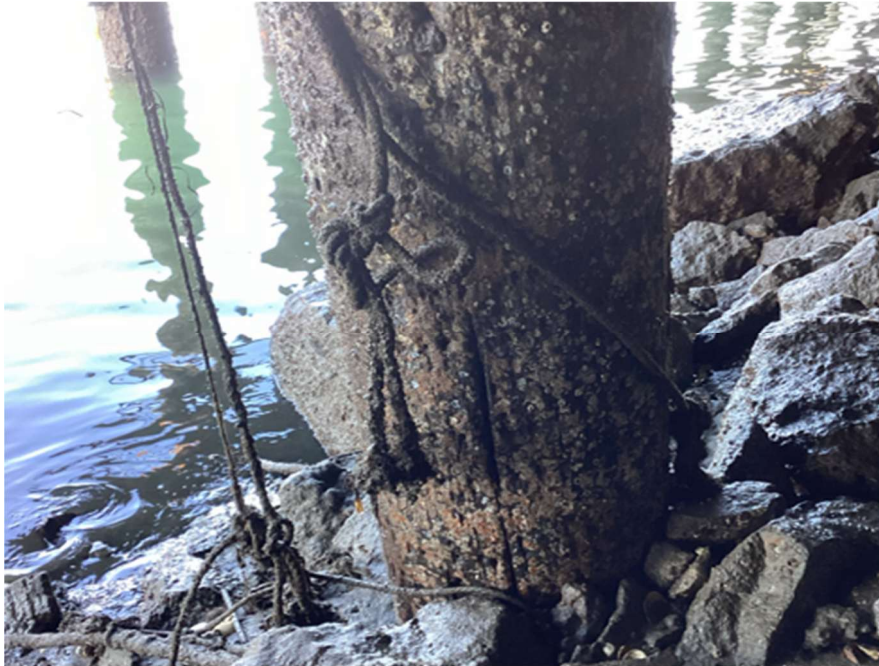
The original structure consists of timber caps that are supported by timber pile. The timber pile were sounded, where accessible, and no decay was found. There was an abundance of marine growth along the pile near the tidal zone, which was expected. There were some checks on many of the pile, but overall, the pile were in good condition. Similar to the pile, the timber caps were also sounded and no decay was identified. There are some light drying checks, but nothing larger than 1/8-inch. Several caps were heavily saturated from water infiltrating the deck. This was predominantly located near the end of the dock where active unloading was being conducted.

Timber Pile Checking

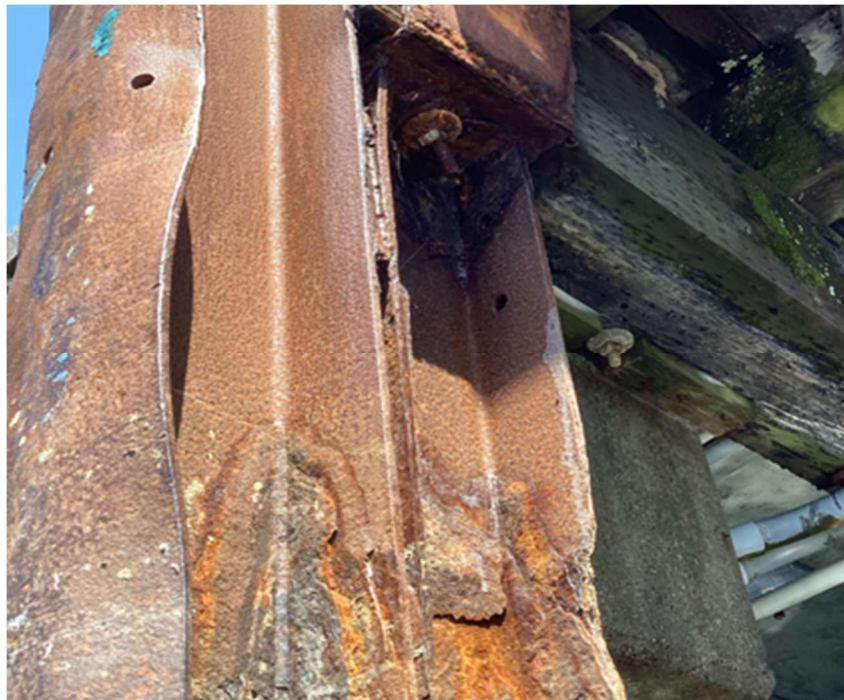
There are several steel H-pile along the exterior end of the original dock. These pile appear to have replaced the original timber pile and are heavily corroded with over 50% section loss.

Exterior Steel Pile Corrosion

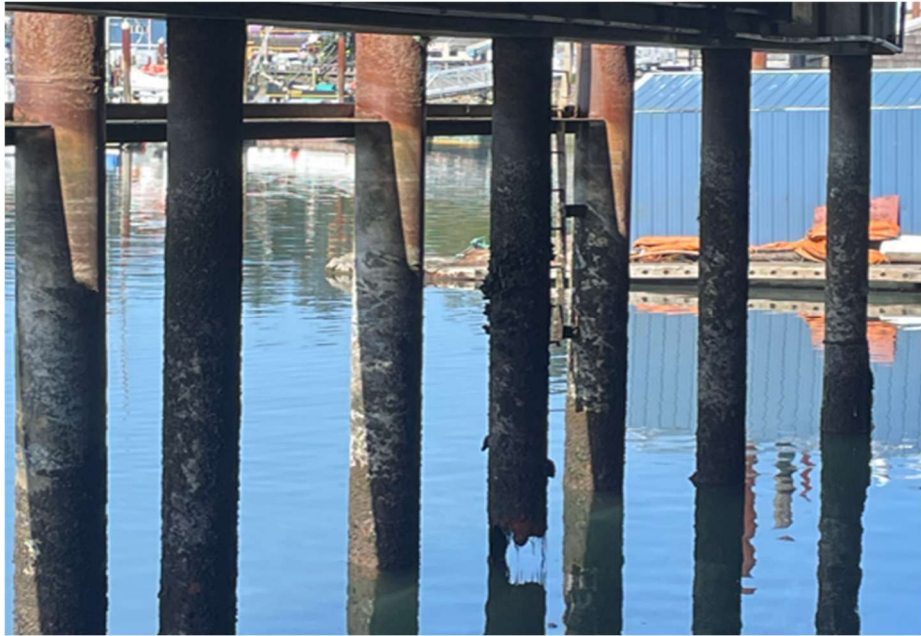
The steel pile are uncoated and are heavily corroded. The heavier corrosion was identified at the top 1-foot of the pile and along the tidal zone. The pile have extensive laminar corrosion, heavy pitting and severe section loss. The third pile from the west end of the structure was fully severed and no longer supporting load. All pile have heavy marine growth along the tidal zone similar to the timber pile.

Pile 3 at the West End Severed

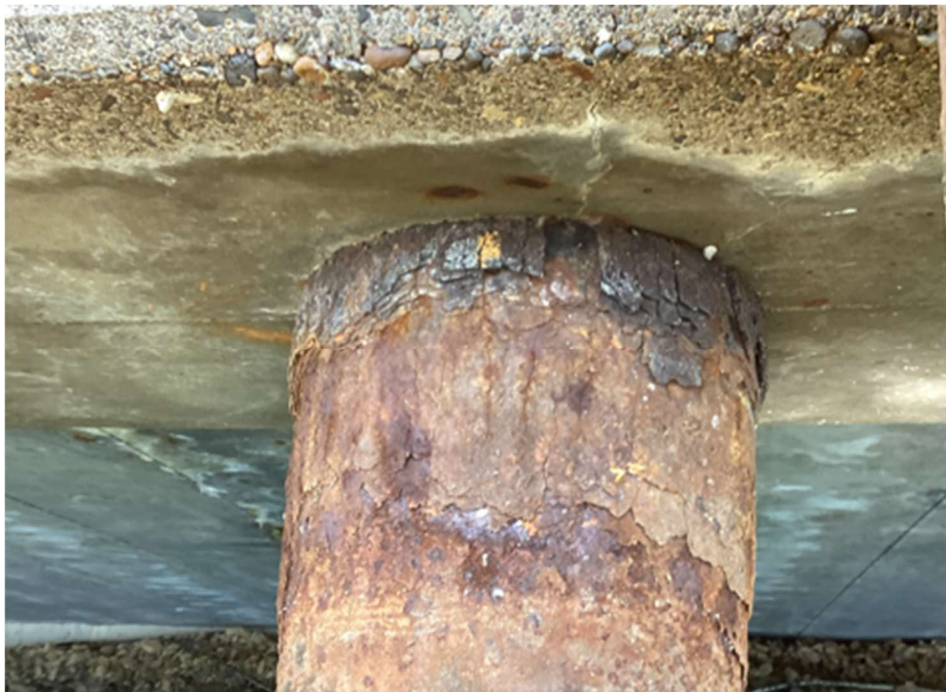
Pile Corrosion at the Cap Interface

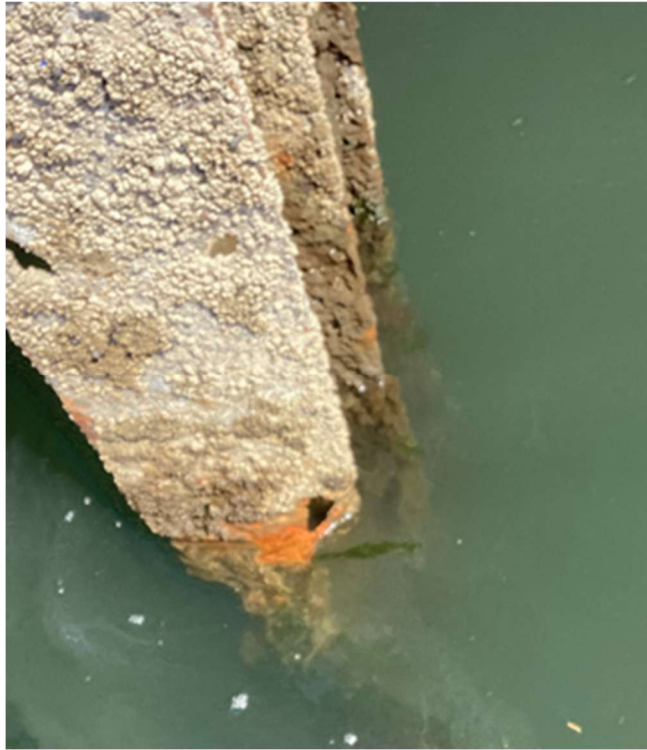
The dock also has steel fender pile that have been installed along the exterior face of the dock. These pile are heavily corroded, especially those that are installed along the older portion of the dock. These pile have over 50% section loss and in time will provide limited protection to the dock.

Fender Pile Corrosion at Waterline
