**PORT OF NEWPORT REGULAR COMMISSION MEETING AGENDA**

Tuesday, December 18, 2018 6:00 p.m.  
South Beach Activities Room  
2120 SE Marine Science Drive, Newport, OR 97365

D. Rogue Seawall Condition Assessment .....	27
VIII. New Business	
A. Commission Meeting Mailing List Policy .....	79
IX. Staff Reports	
A. Accounting Supervisor.....	87

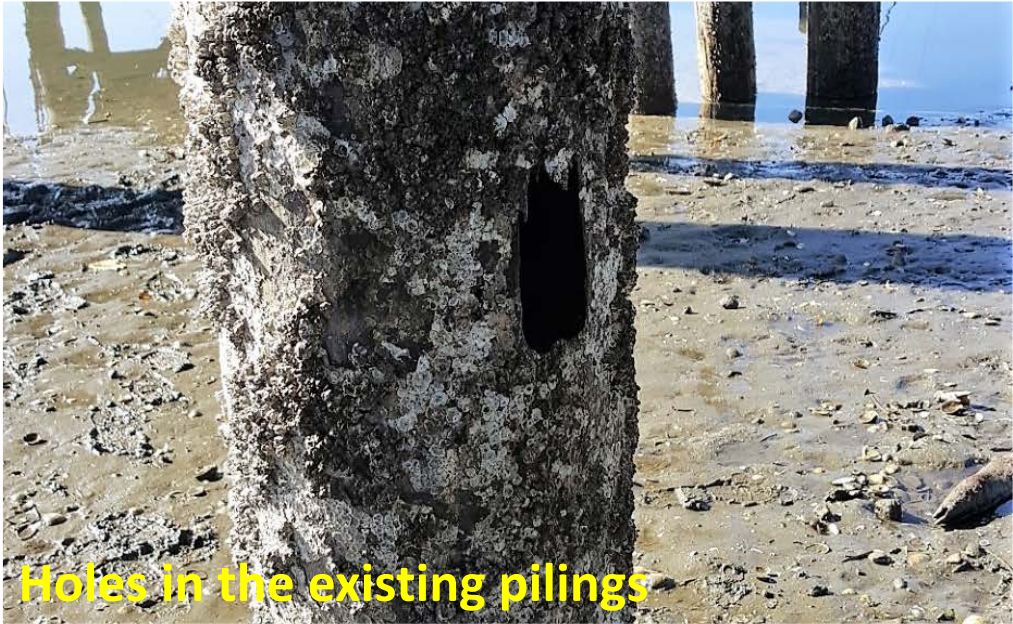
- The bridge from the shore to the floating Port Dock 5 complex is a dilapidated wooden pier of late 1960's vintage called the Port Dock 5 Pier.
- The cores of the wooden pilings supporting the Port Dock 5 Pier have rotted away; many of those pilings are now hollow, and the pier is in danger of failing.

Holes in the existing pilings

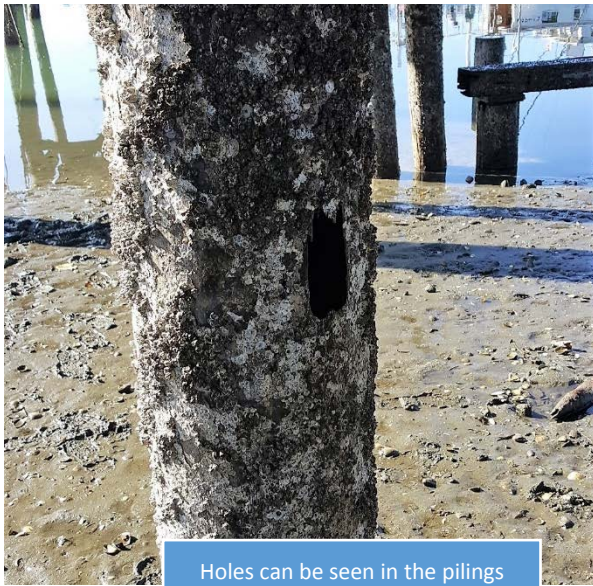
Holes can be seen in the pilings beneath Port Dock 5

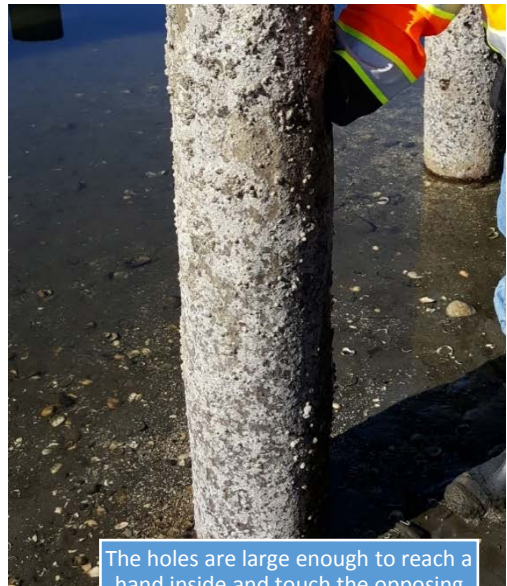
The holes are large enough to reach a hand inside and touch the opposing side

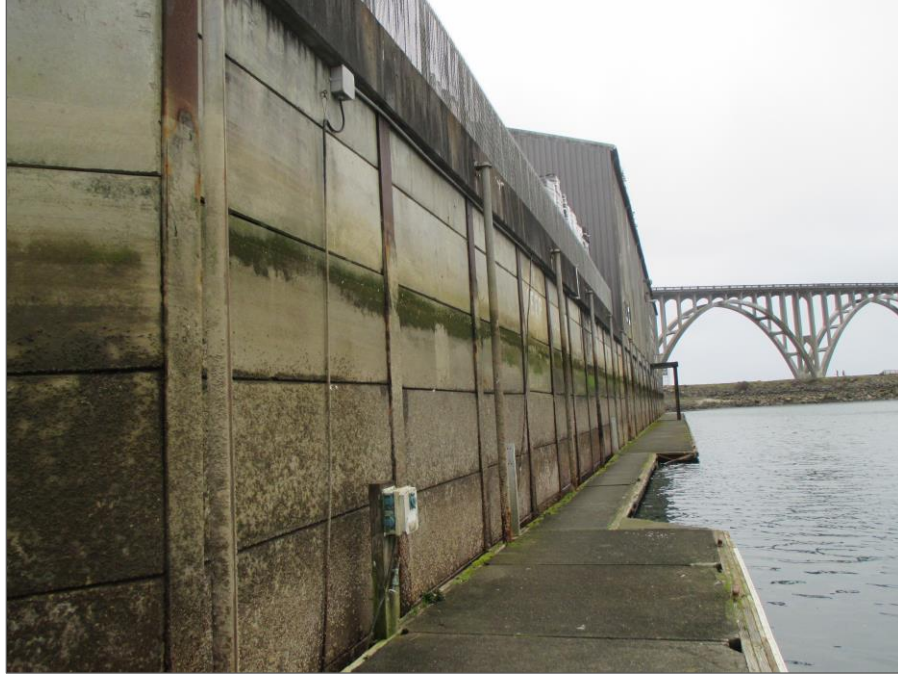
**1(a). Corrosion on soldier piles  
(27 February 2018)**

Figure 1 (a through e) shows the typical damage to the soldier piles. There is corrosion damage visible as laminated rust in two zones (a) the tide splash zone (elevation -3 feet to elevation +10 feet on average) and (b) below the cap beam on the all soldier piles. Considerable expansion was observed on the seaside pile flange showing a thickness increasing to approximately 1-1/4 to 2 inches (originally 0.87 inch for W18x97).

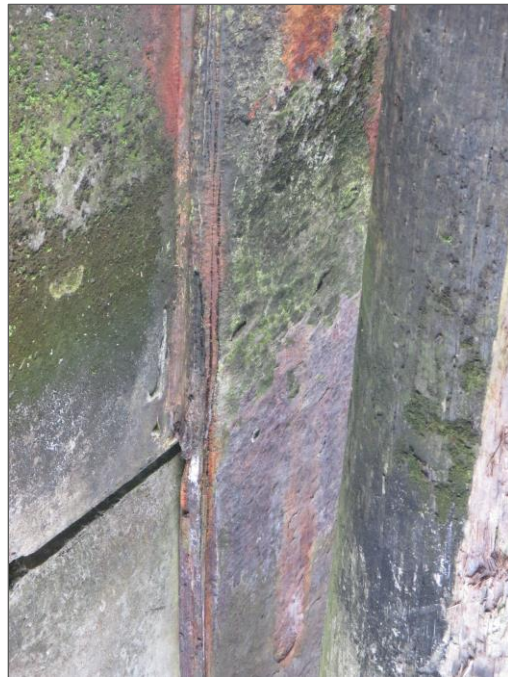
**1(b). Typical chloride-induced corrosion damage in splash zone  
(27 February 2018)**

The damage is also severe below the pile cap where there is no direct water contact. This is due to the geometry of the corroded area, where the pitting and crevice corrosion possibilities are higher than smooth areas. The chloride-induced corrosion is more probable in locations where the access to oxygen is more limited because of specific geometric configurations like corners, etc.

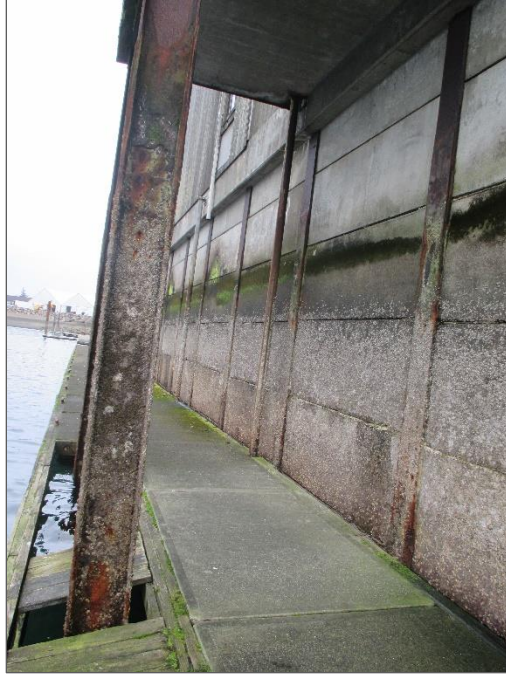
The concrete laggings are in generally good condition in terms of concrete surface quality (cracks, spalling, etc.) and vertical alignments. Figure 2 shows a typical lagging condition.

**Figure 2. Concrete lagging existing conditions**  
(There are surface effects from water; however, the overall visual inspection seemed acceptable at this point.)

Some minor sulfate attack and carbonation issues were found during the visual inspections. The corrosion or degradation due to carbon or sulfates can be monitored and prevented with service-life modeling and design, probably with coating. This is a less severe damage mechanism than chloride-induced corrosion, but can be resolved when corrosion inhibitors are applied.

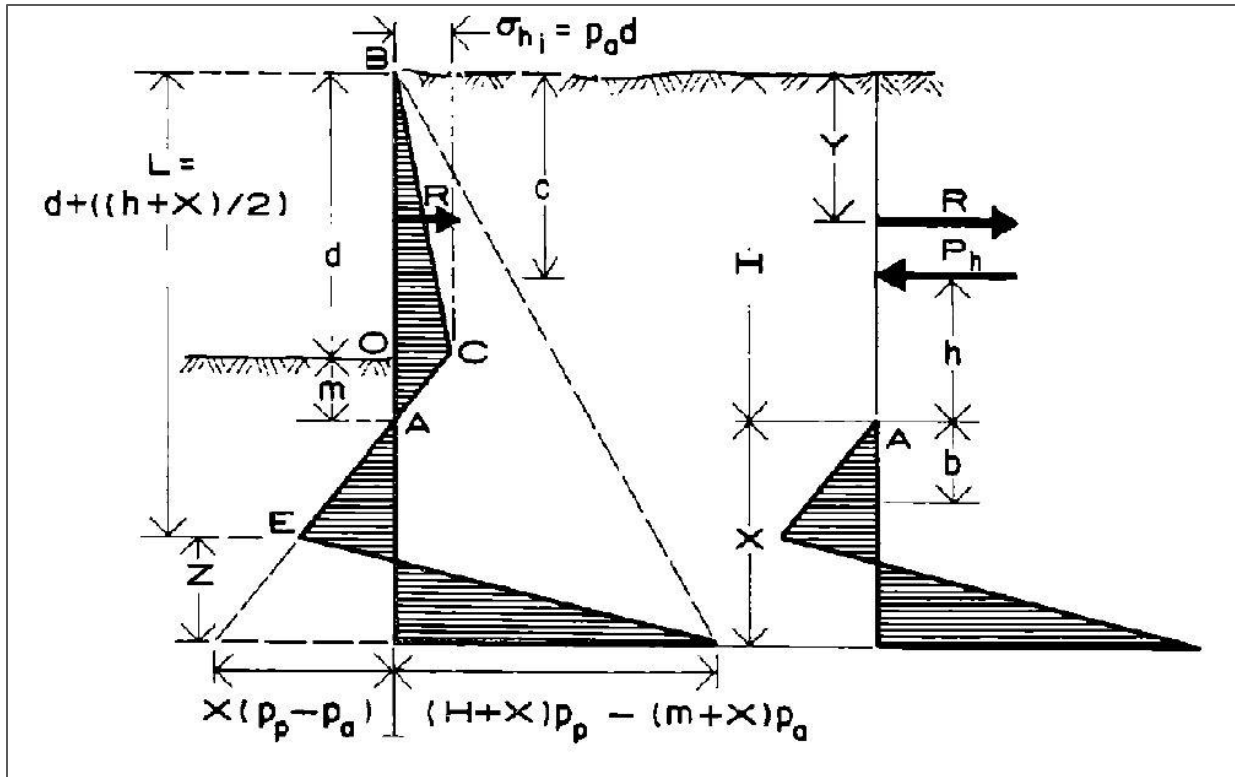
Figure 4 shows the loading assumption on the soldier pile with tie-back wall. According to as-built drawings, the piles were not driven to bedrock. The tie-back and W-sections will be rechecked based on AISC-ASD for the tallest piles (Pile Nos. 7 through 52).

**Figure 4. Backfill loading on soldier piles**  
 (Reference: Retaining Wall Design Guide, FHWA-FLP 94006)

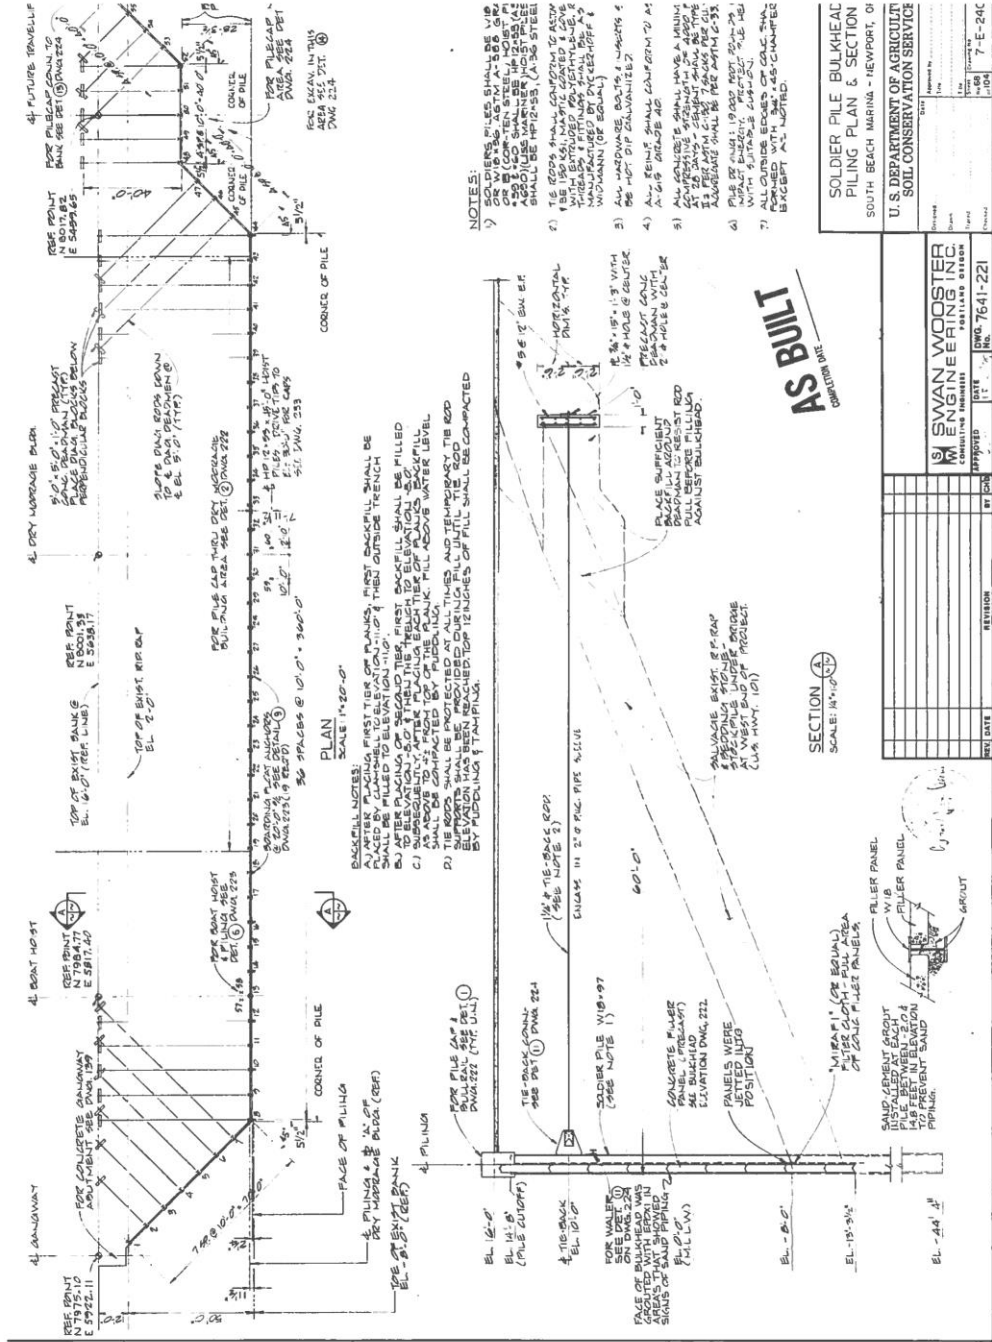
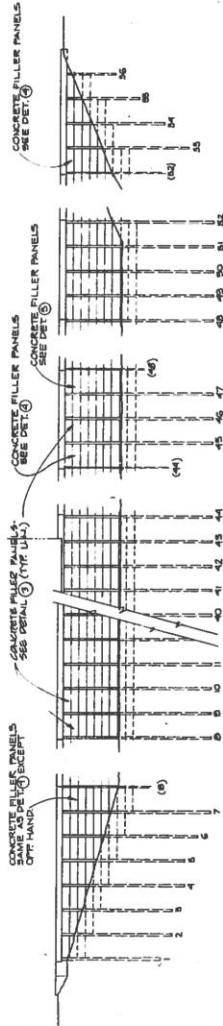
**BULKHEAD ELEVATION**

PILE	TIP ELEV.	LENGTH
1	-19'-4"	35'
2	-19'-4"	35'
3	-24'-4"	40'
4	-28'-4"	45'
5	-34'-4"	50'
6	-38'-4"	55'
7	-44'-4"	60'
8	-44'-4"	60'
9	-44'-4"	60'
10	-44'-4"	60'
11	-44'-4"	60'
12	-44'-4"	60'
13	-44'-4"	60'
14	-44'-4"	60'
15	-44'-4"	60'
16	-44'-4"	60'
17	-44'-4"	60'
18	-44'-4"	60'
19	-44'-4"	60'
20	-44'-4"	60'

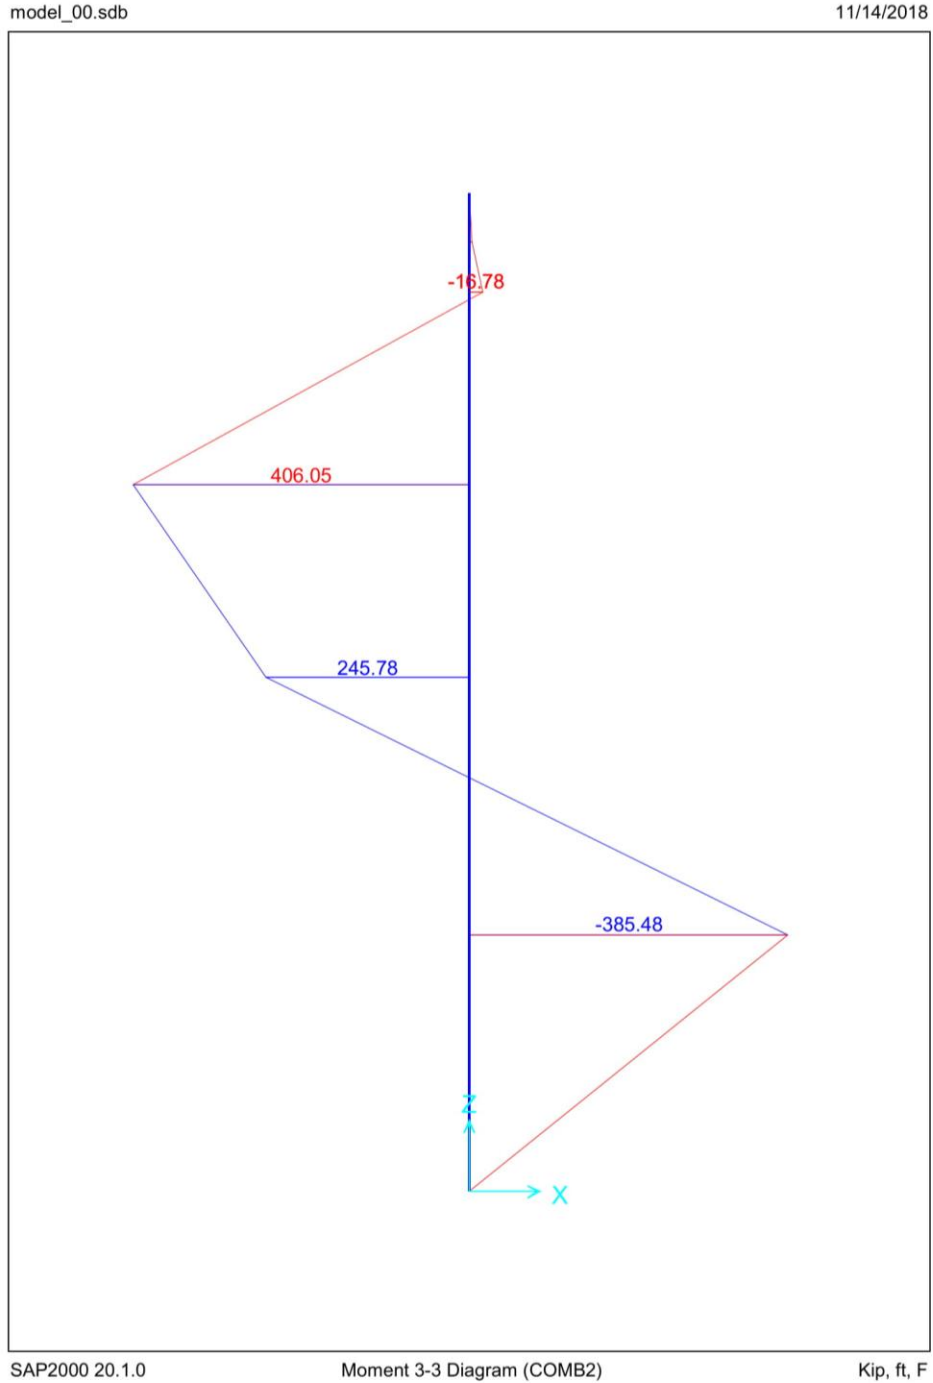
**Appendix D  
SOLDIER PILE WALL MODELING RESULTS**

Assuming the backfill active and passive pressures and a 3-foot unbalanced water level behind the wall, the following moment diagram is obtained for the soldier pile. The maximum moment for this diagram is used for checking the initial and existing pile and tie-back.
