Geotechnical Data Report Port of Newport Continuing Authority Program 107 Project

Newport, Oregon

October 25, 2024

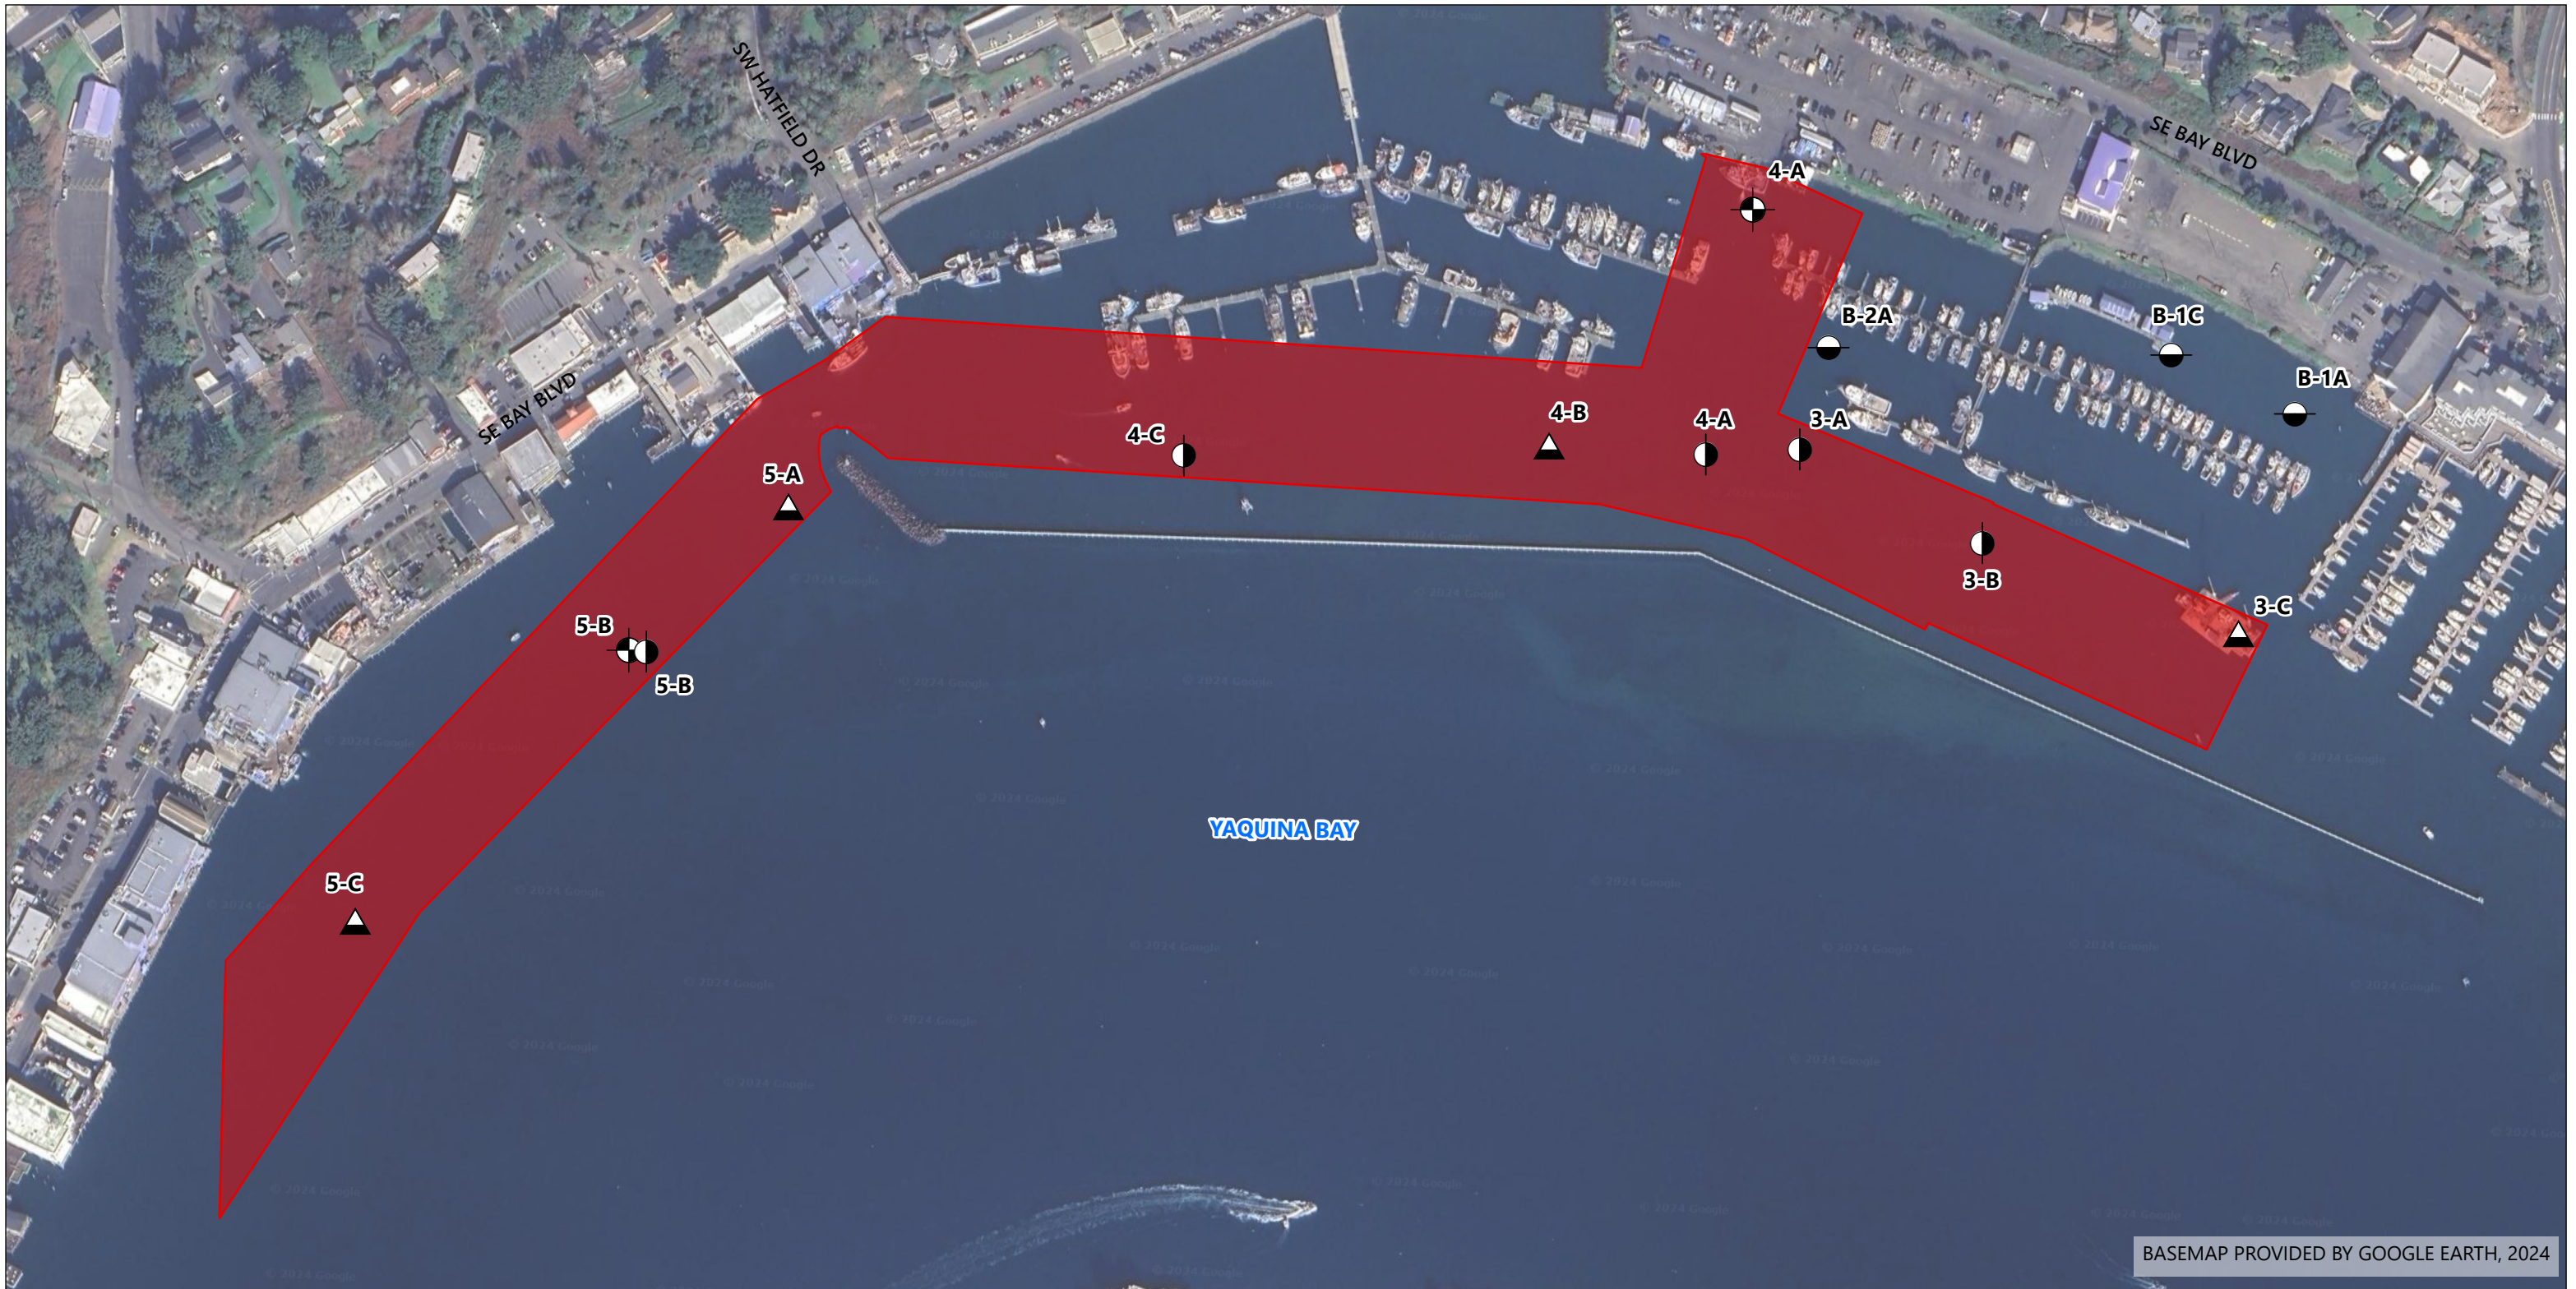
SITE PLAN

The Yaquina CAP 107 project CMAC dredging area is west of the breakwater, as shown on the Site Plan, Figure 2. The dredging area is approximately 1,400 feet long and 180 feet wide, with a dredge depth elevation of -20 feet. Within the breakwater, the dredging area is about 2,250 feet long and varies from about 220 feet to 570 feet wide, with a dredge depth elevation of -22 feet.

The subsurface exploration program for this phase of the project was completed during two separate mobilizations. Drilling during the first mobilization occurred between February 20 and 23, 2024, and included five rotosonic borings designated 3-C, 4-A, 4-B, 5-B, and 5-C. Drilling during the second mobilization occurred on March 13, 2024, with one mud-rotary boring designated 5-A. The approximate locations of the borings are shown on the Site Plan, Figure 2.

findings submitted in this report are based on the data obtained from the subsurface explorations made at the locations indicated on Figure 2 and other sources of information discussed in this report. In the performance of subsurface investigations, specific information is obtained at specific locations at specific times. However, it is acknowledged that variations in subsurface conditions may exist between exploration locations. This report does not reflect variations that may occur between these explorations.

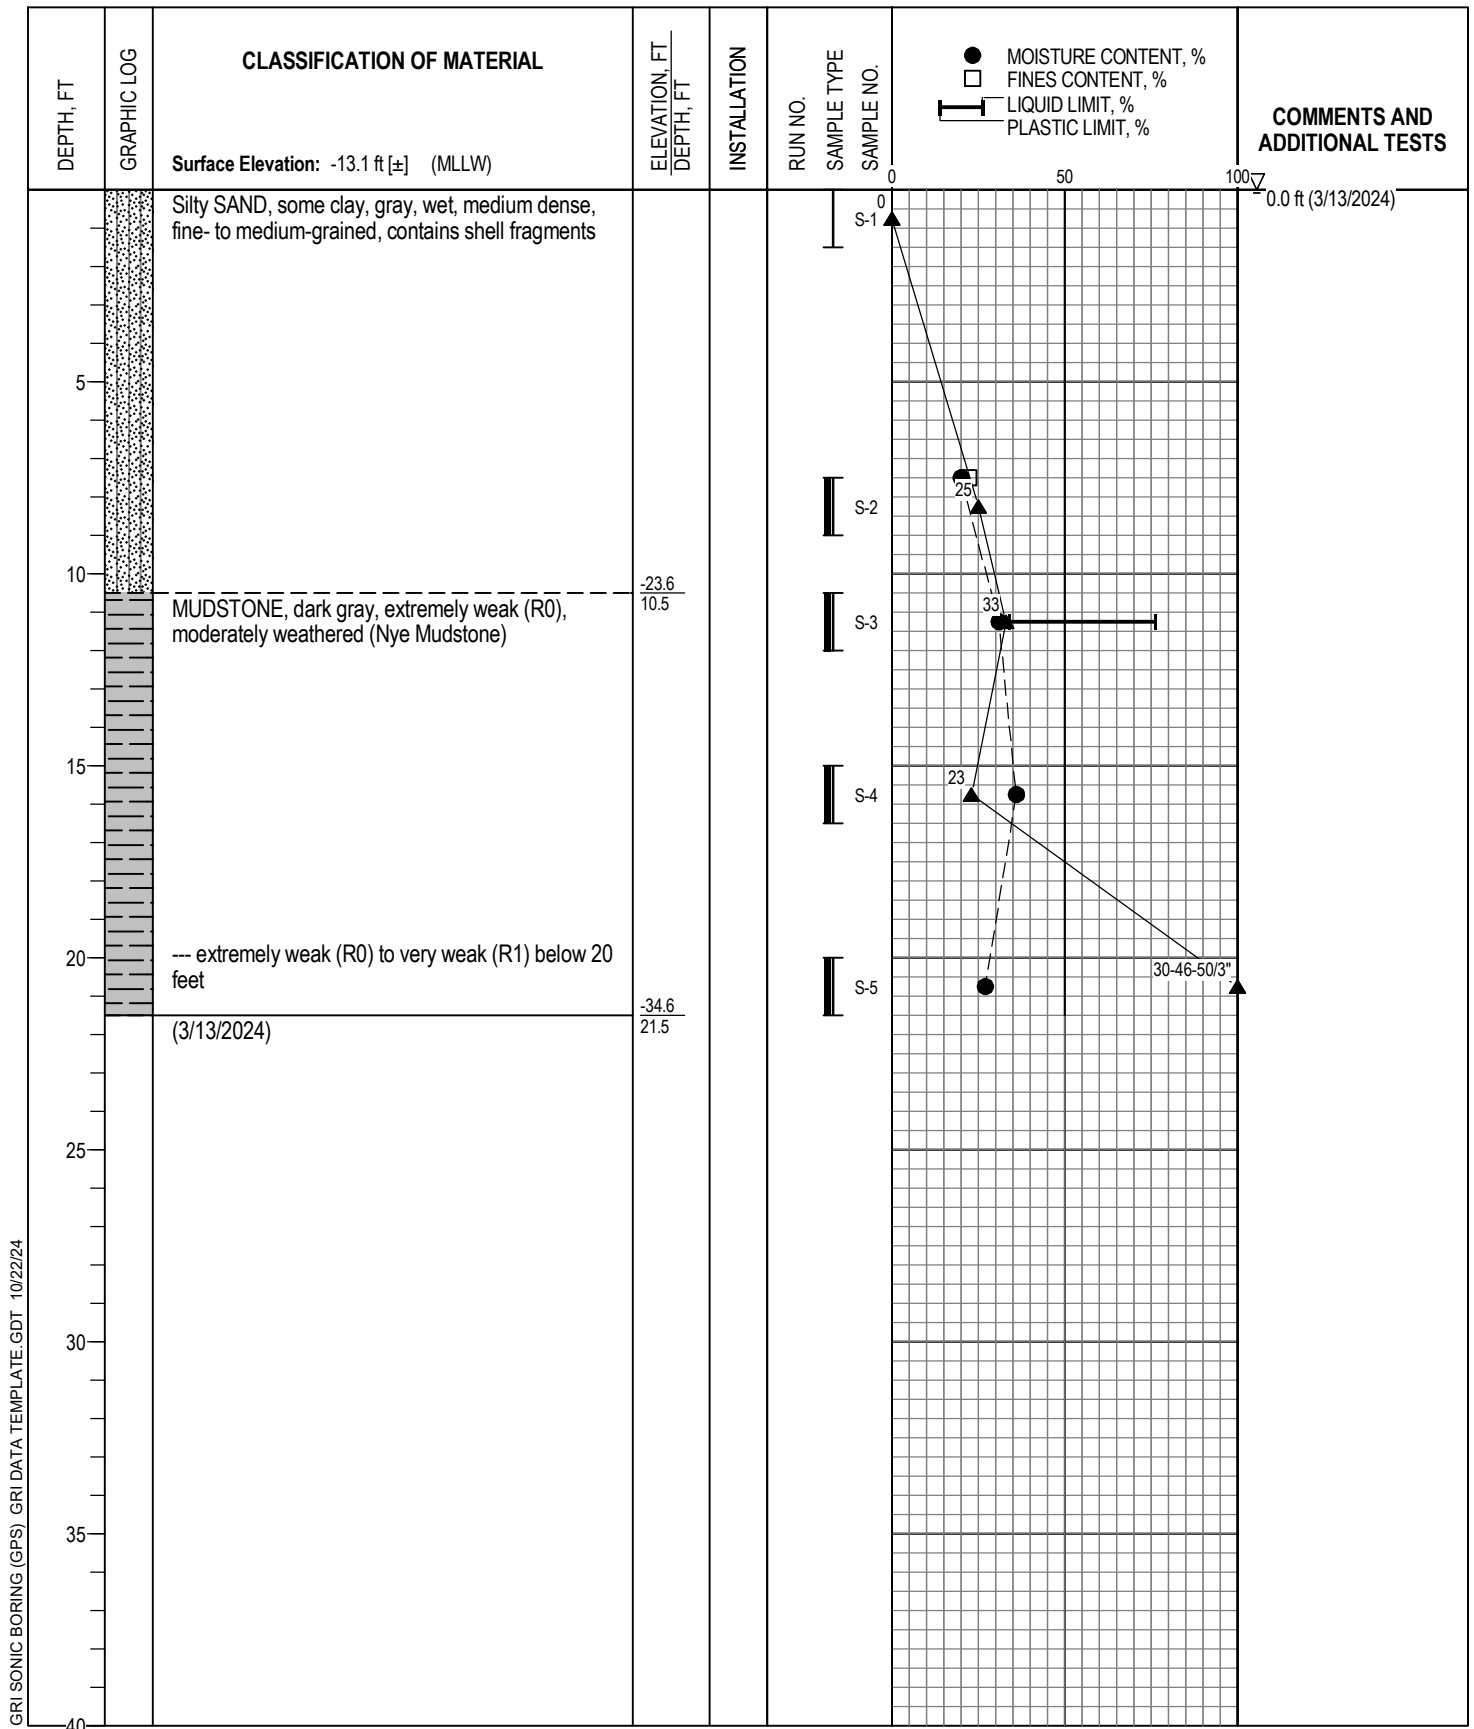
BORING 5-A

Logged By: A. Horst		Drilled by: Western States Soil Conservation, Inc.	
Date Started: 3/13/24	GPS Coordinates: 44.6297565° N -124.0514345° W (WGS 84)		
Drilling Method: Mud Rotary	Equipment: Geoprobe Sonic 8150		Hammer Type: Auto Hammer
Hole Diameter: 5 in.			Weight: 140 lb
Note: See Legend for Explanation of Symbols			Drop: 30 in.
			Energy Ratio: 0.8

A log of the mud-rotary boring is provided on Figure 4A. The log presents a descriptive summary of the various types of materials encountered in the boring and notes the depth at which the materials and/or characteristics of the materials change. To the right of the descriptive summary, the numbers and types of samples are indicated. Farther to the right, N-values are shown graphically, along with the natural moisture content and Atterberg limits determinations. The terms used to describe the materials encountered in the boring are defined in Tables 1A and 2A.

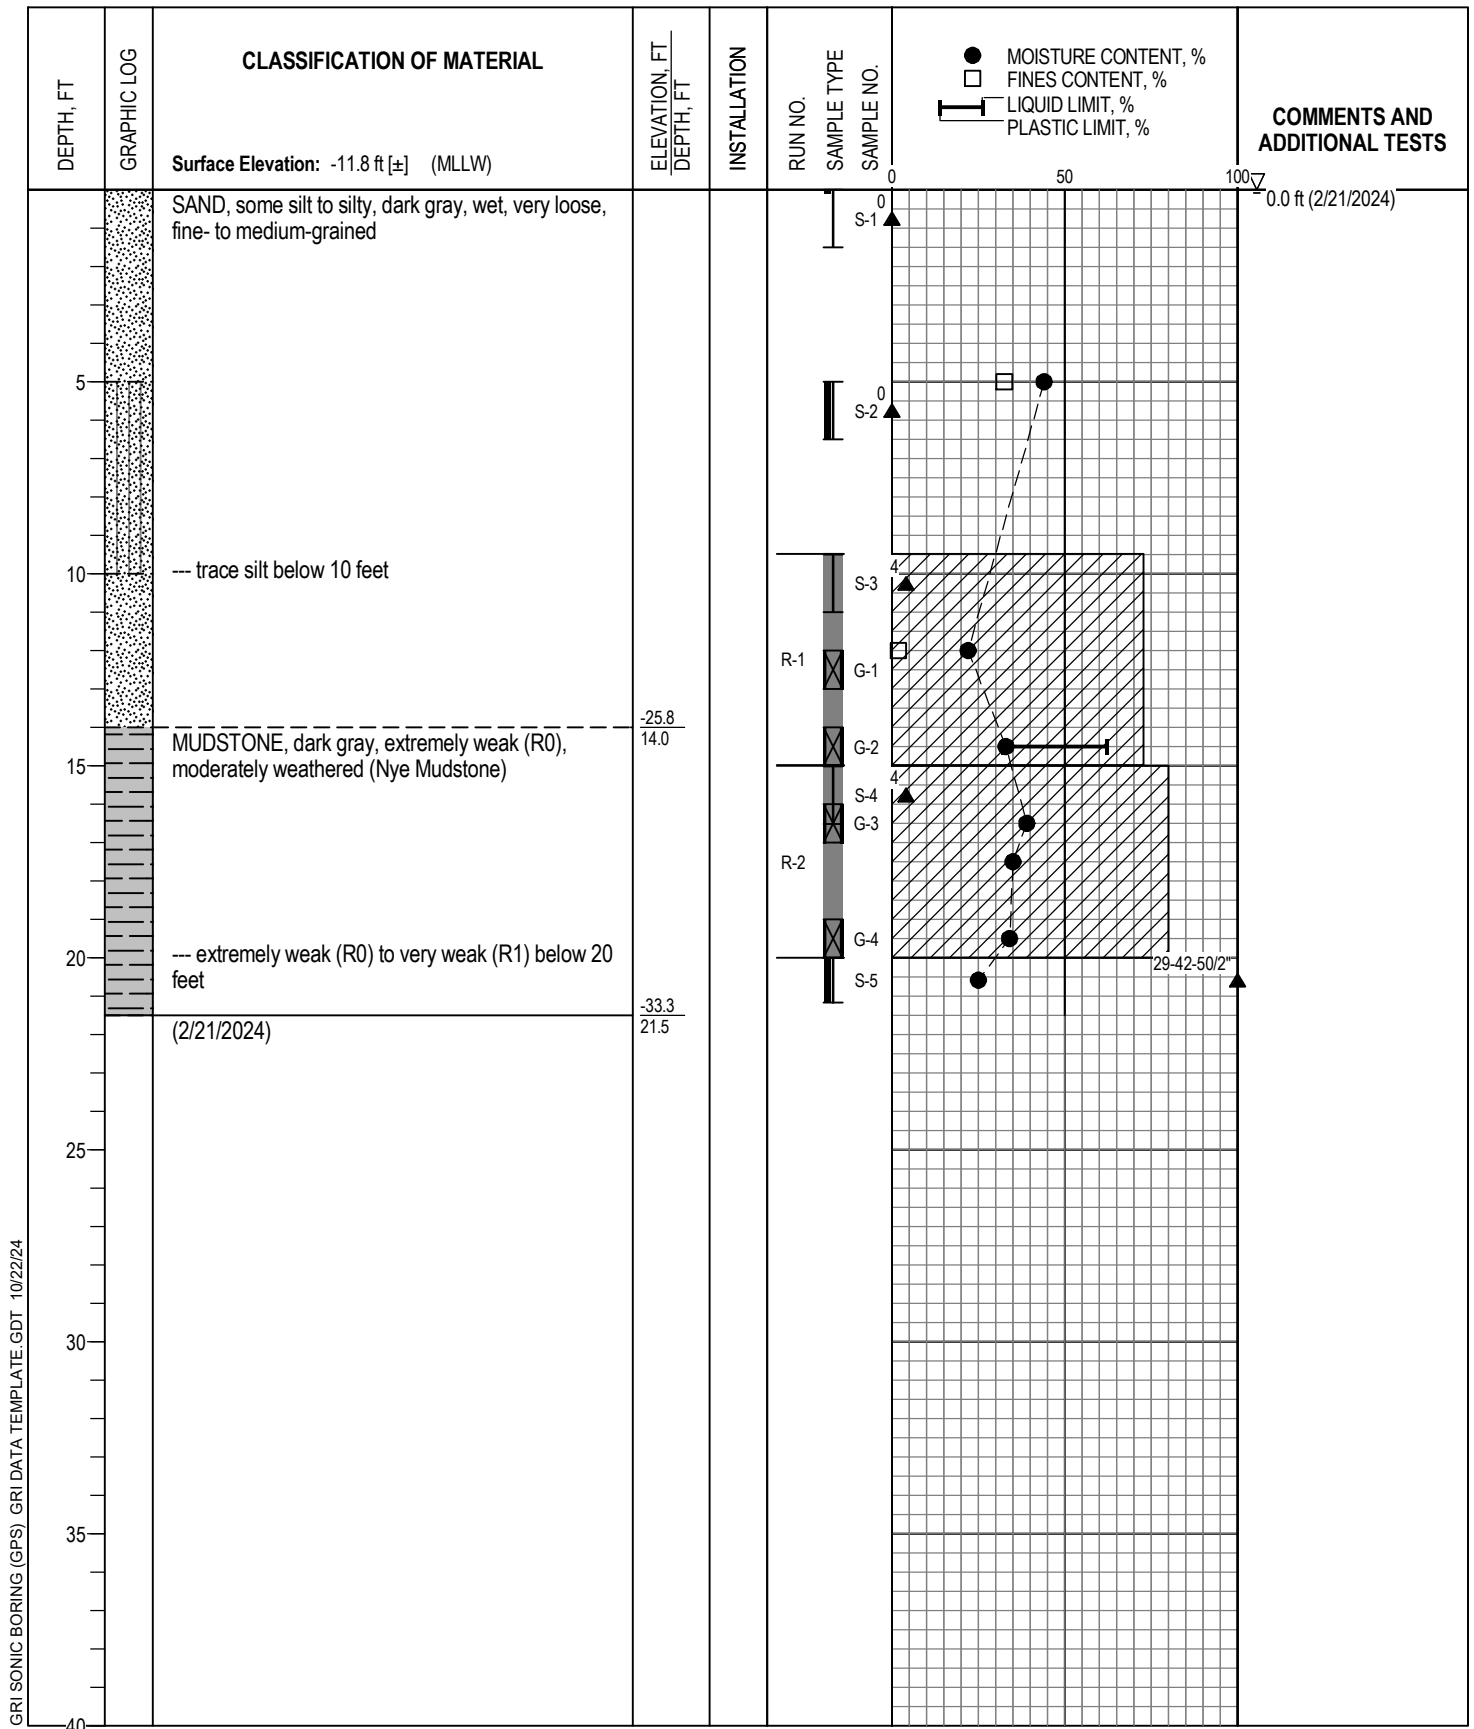
BORING 5-B

Logged By: A. Horst		Drilled by: Western States Soil Conservation, Inc.	
Date Started: 2/21/24		GPS Coordinates: 44.629136° N -124.0523556° W (WGS 84)	
Drilling Method: Roto Sonic		Hammer Type: Auto Hammer	
Equipment: Geoprobe Sonic 8150		Weight: 140 lb	
Hole Diameter: 5 in.		Drop: 30 in.	
Note: See Legend for Explanation of Symbols		Energy Ratio: 0.88

Logs of the rotosonic borings are provided on Figures 1A through 6A. Each log provides a descriptive summary of the various types of material encountered during drilling. To the left of the descriptive summary, a graphic log indicates the general soil type. To the right of the descriptive summary, the numbers and types of soil or rock samples taken during the drilling operation are indicated. Farther to the right, N-values are shown graphically, along with the natural moisture contents, percent material passing the No. 200 sieve, and Atterberg limits determinations. The terms used to describe the materials encountered in the borings are defined in Tables 1A and 2A.

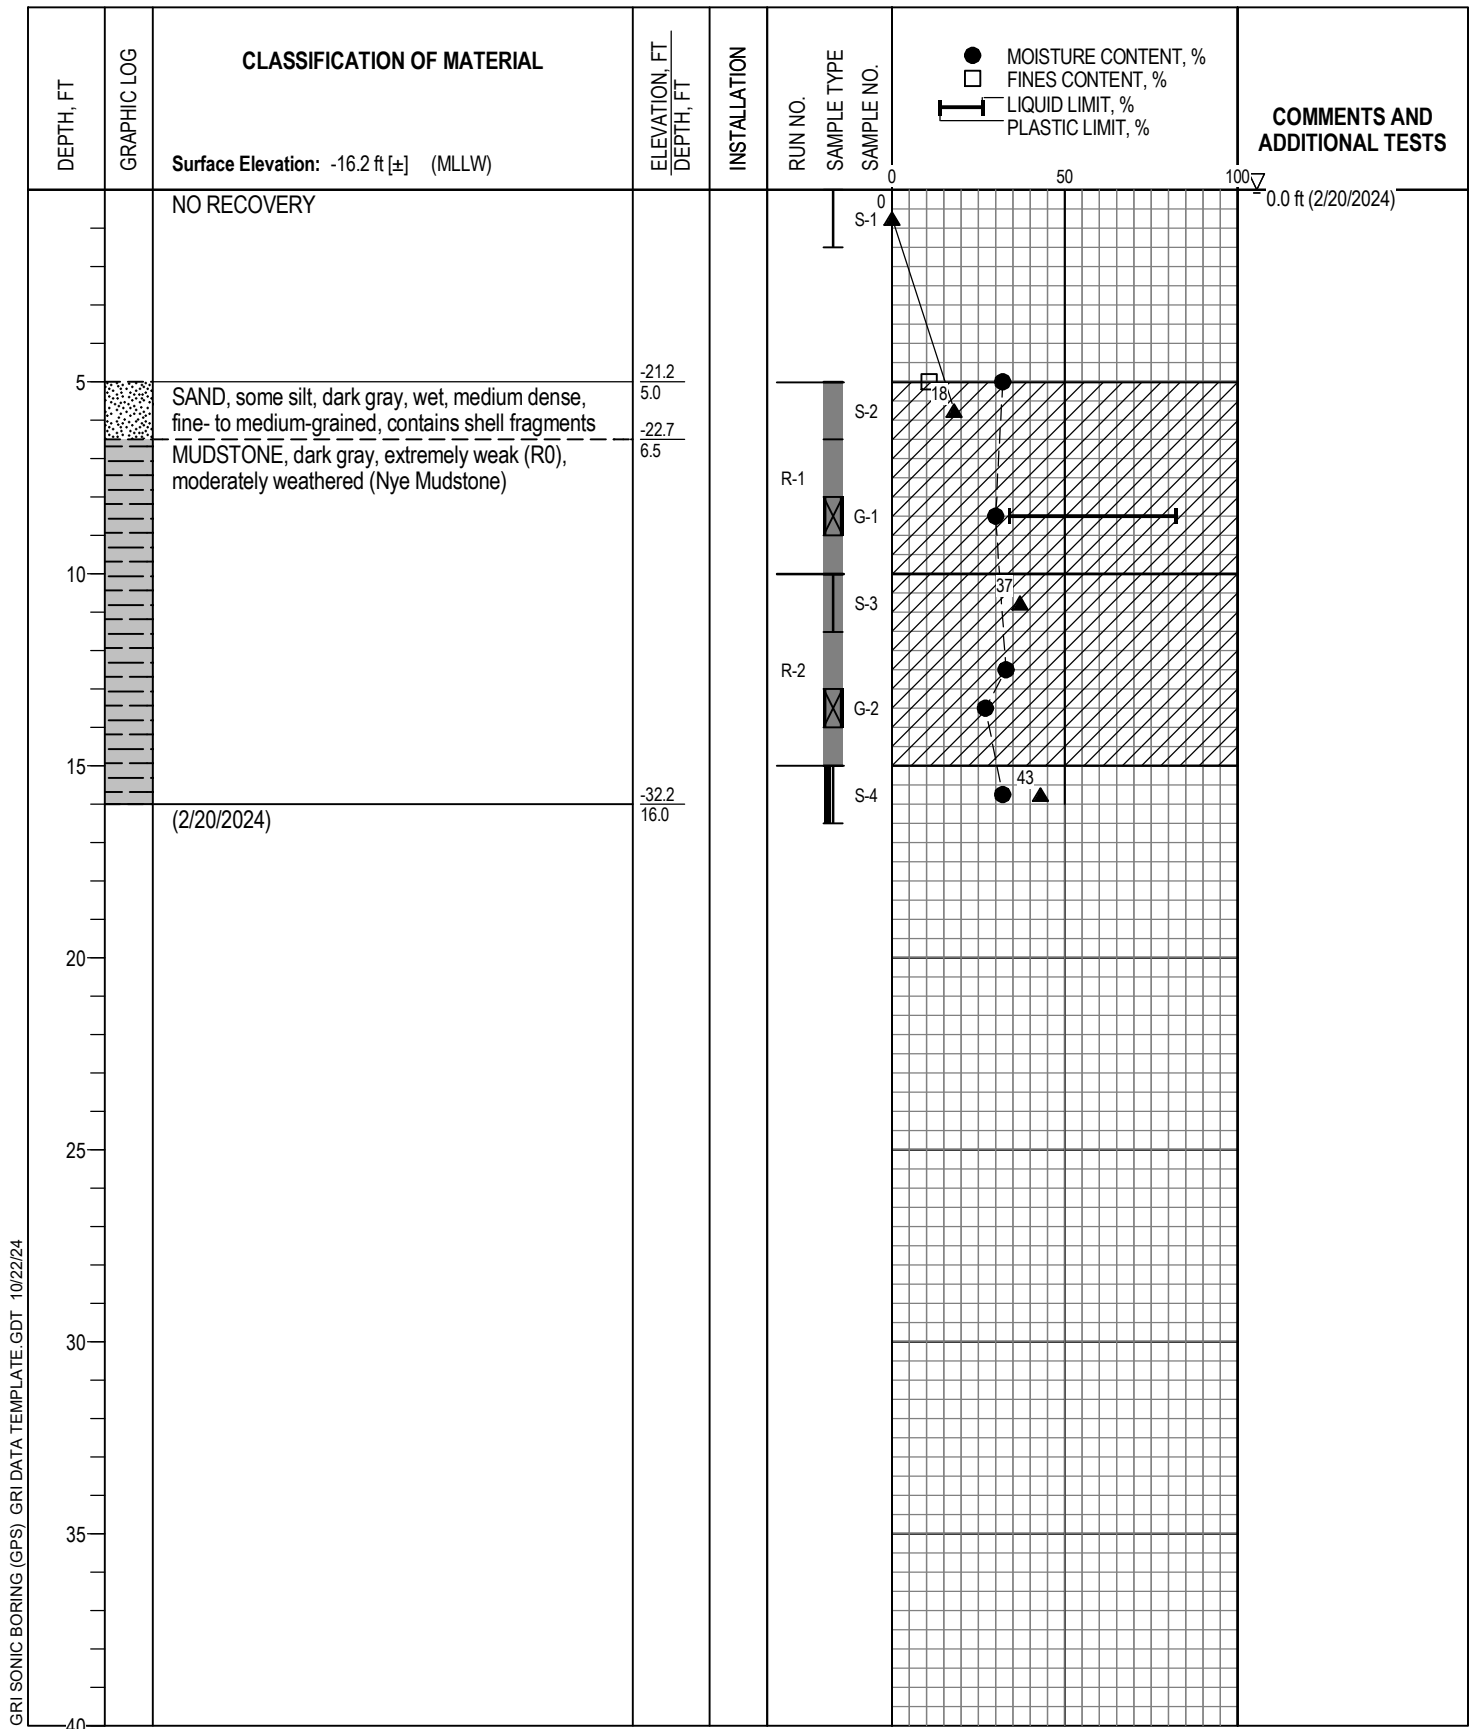
Logged By: A. Horst		Drilled by: Western States Soil Conservation, Inc.	
Date Started: 2/20/24		GPS Coordinates: 44.6278672° N -124.0539529° W (WGS 84)	
Drilling Method: Roto Sonic		Hammer Type: Auto Hammer	
Equipment: Geoprobe Sonic 8150		Weight: 140 lb	
Hole Diameter: 5 in.		Drop: 30 in.	
Note: See Legend for Explanation of Symbols		Energy Ratio: 0.88

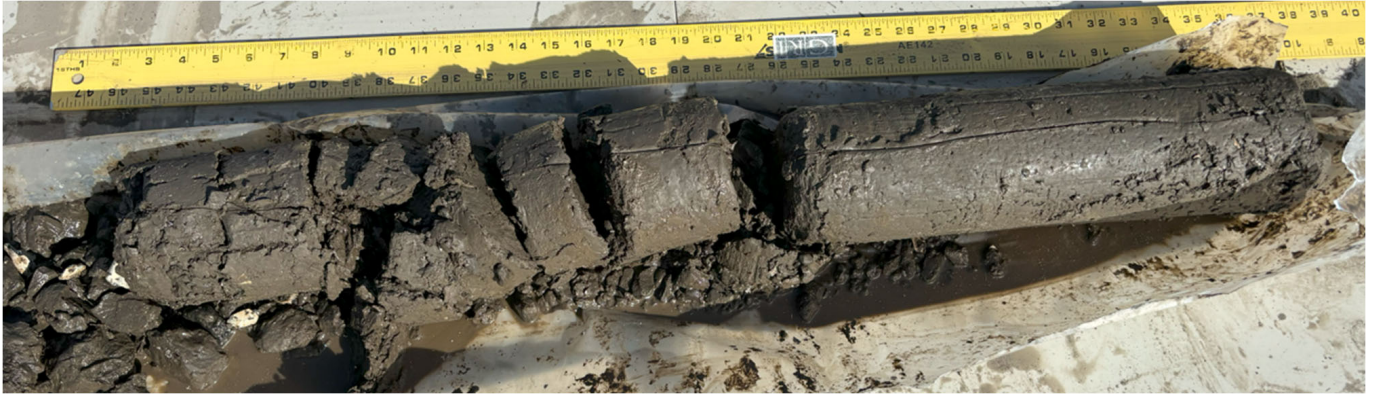
6801-B: BORING 3-C: CORE RUN 1 (ELEVATION -26.2 FEET TO -31.2 FEET)

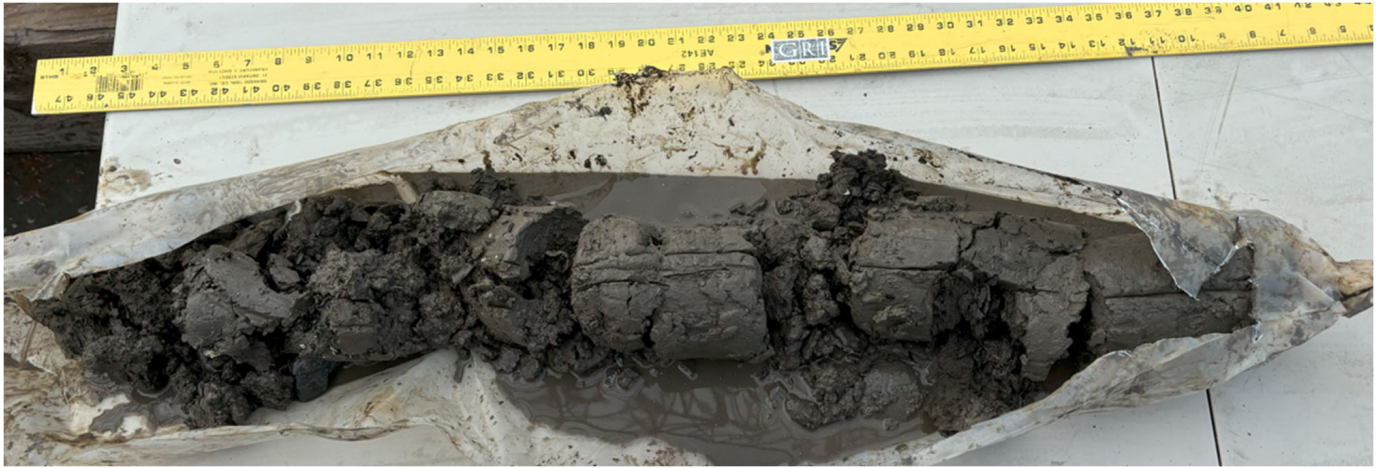
6801-B: BORING 4-A: CORE RUN1 (ELEVATION -14.8 FEET TO -19.8 FEET)

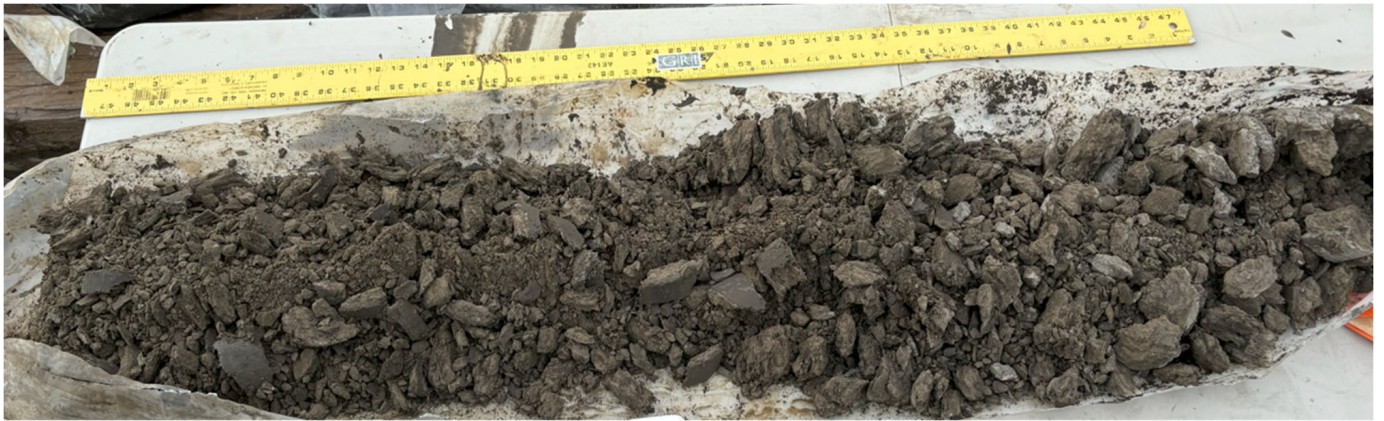
6801-B: BORING 4-A: CORE RUN 2 (ELEVATION -21.3 FEET TO -26.3 FEET)

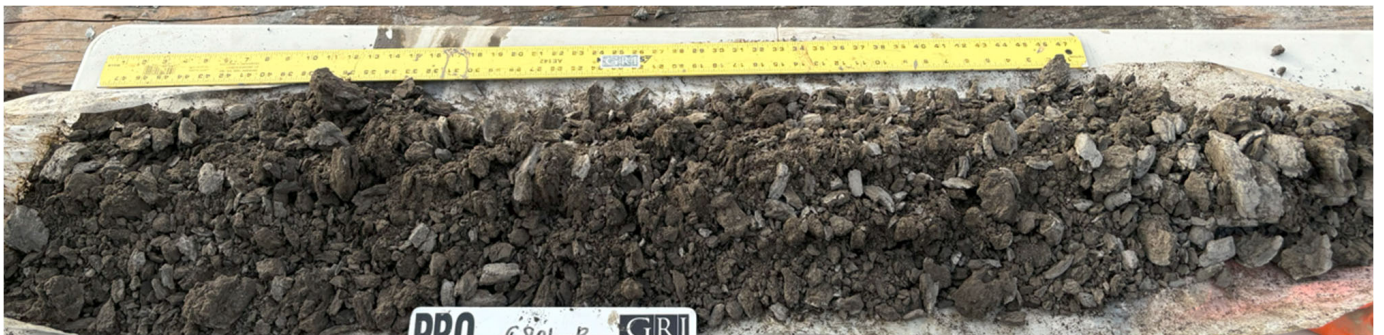
6801-B: BORING 4-A: CORE RUN 3 (ELEVATION -26.3 FEET TO -31.8 FEET)

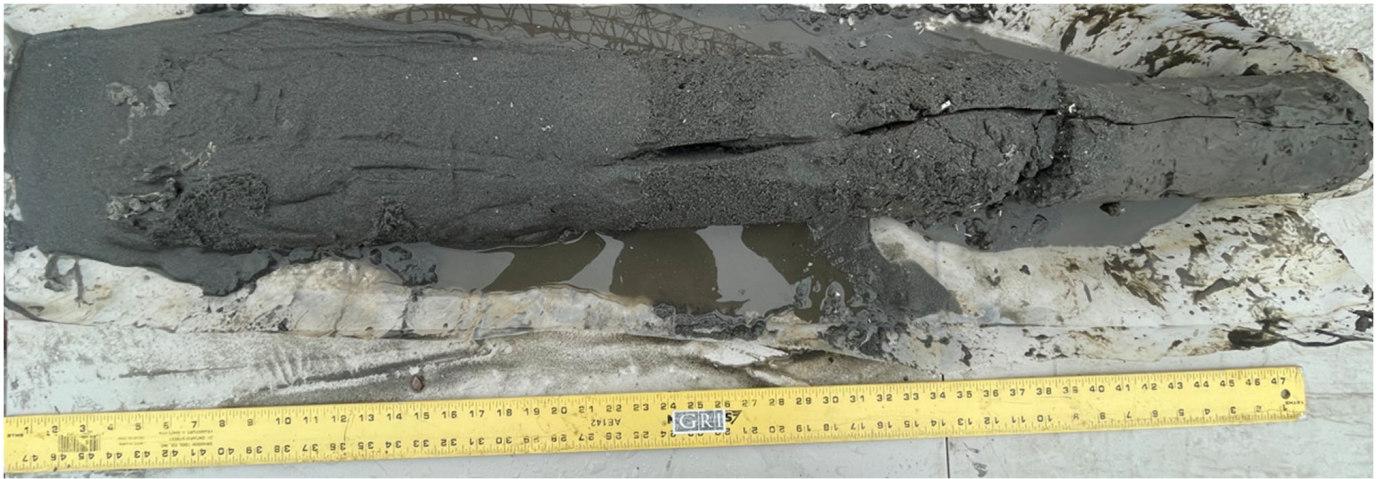
6801-B: BORING 5-B: CORE RUN 1 (ELEVATION -22.6 FEET TO -27.6 FEET)

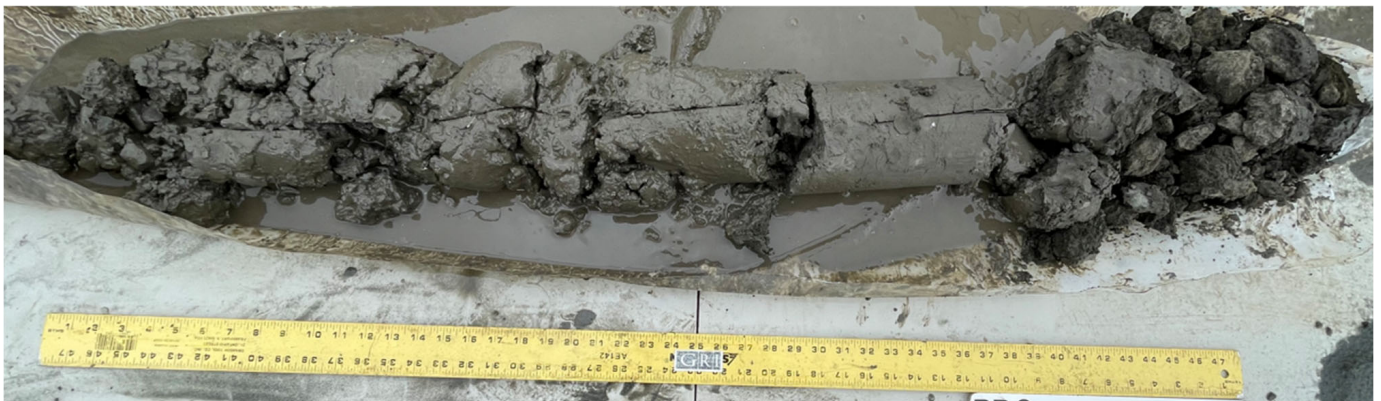
6801-B: BORING 5-B: CORE RUN 2 (ELEVATION -27.6 FEET TO -32.6 FEET)

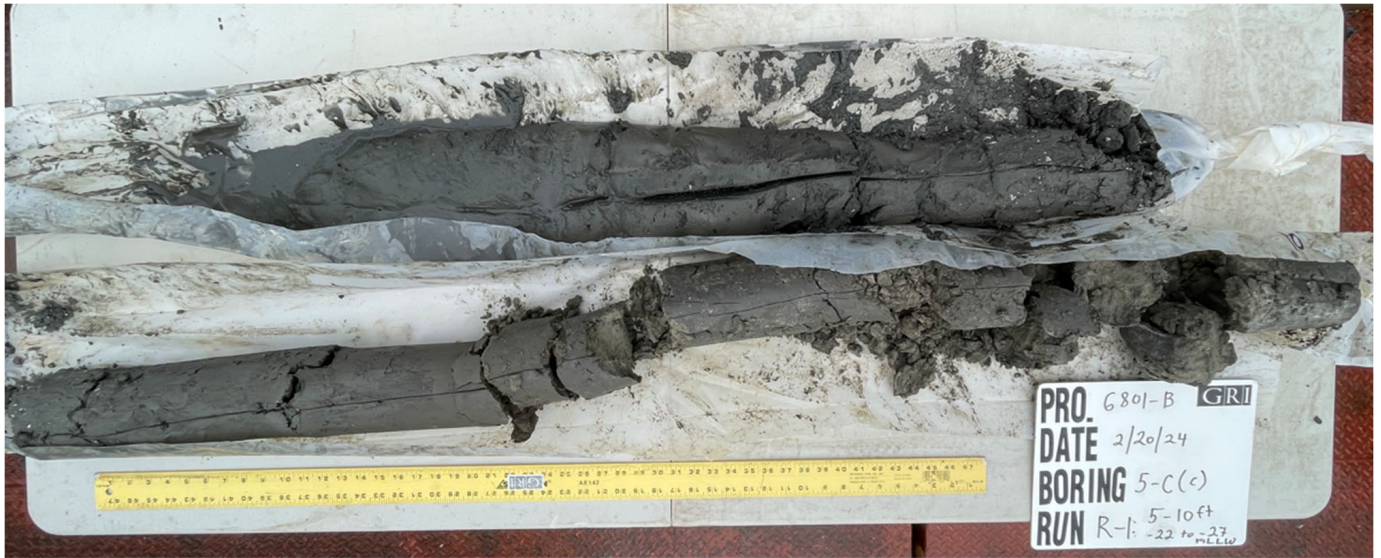
6801-B: BORING 5-C: CORE RUN 1 (ELEVATION -22 FEET TO -27 FEET)

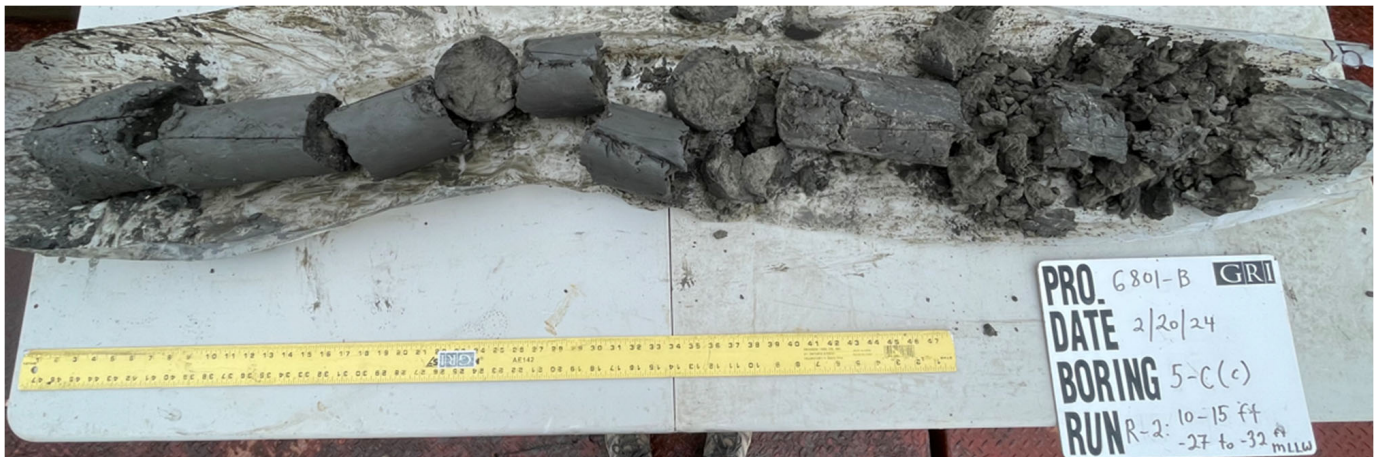
6801-B: BORING 5-C: CORE RUN 2 (ELEVATION -27 FEET TO -32 FEET)

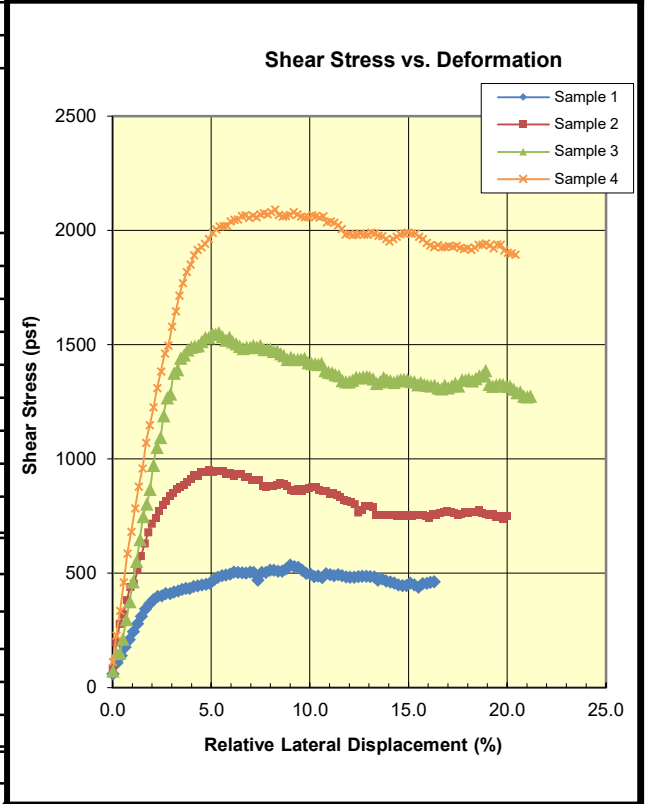
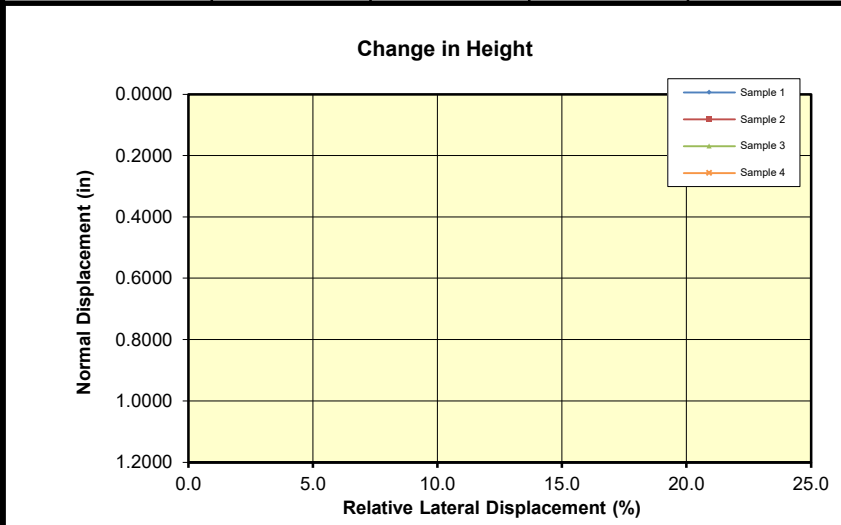
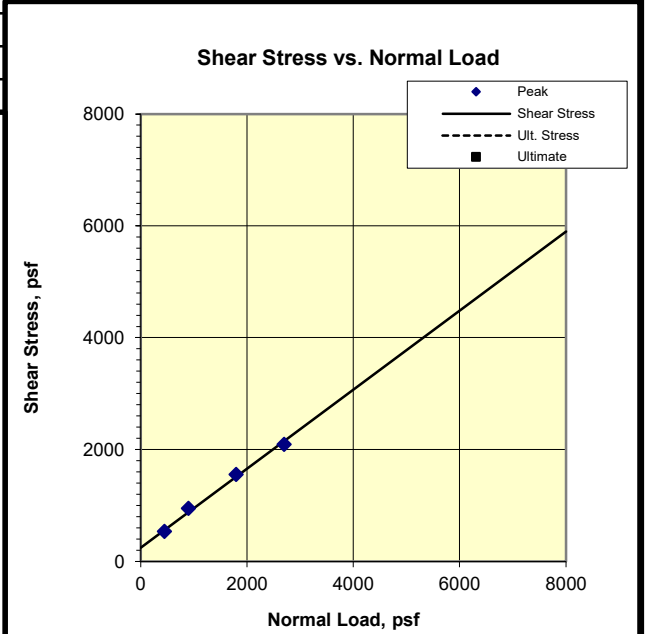
Specimen Data				
	1	2	3	4
Boring:	5-B	5-B	5-B	5-B
Sample:	G-1	G-1	G-1	G-1
Depth (ft):	12-13	12-13	12-13	12-13
Visual Description:	Dark Greenish Gray SAND	Dark Greenish Gray SAND	Dark Greenish Gray SAND	Dark Greenish Gray SAND
Normal Load (psf)	450	900	1800	2700
Dry Mass of Specimen (g)	104.1	107.2	107.0	103.3
Initial Height (in)	1.00	1.00	1.00	1.00
Initial Diameter (in)	2.42	2.42	2.42	2.42
Initial Void Ratio	0.955	0.898	0.901	0.971
Initial Moisture (%)	22.1	22.2	23.0	22.6
Initial Wet Density (pcf)	105.2	108.5	109.1	104.9
Initial Dry Density (pcf)	86.2	88.8	88.7	85.5
Initial Saturation (%)	62.4	66.6	69.0	62.8
ΔHeight Consol (in)	0.0170	0.0160	0.0218	0.0305
At Test Void Ratio	0.922	0.868	0.860	0.911
At Test Moisture (%)	23.1	23.0	22.4	22.6
At Test Wet Density (pcf)	108.0	111.0	110.9	108.1
At Test Dry Density (pcf)	87.7	90.2	90.6	88.2
At Test Saturation (%)	67.7	71.6	70.3	67.0
Strain Rate (%/min)	1.2	1.1	1.0	1.1

Strengths Picked at	Peak	Peak	Peak	Peak
Shear Stress (psf)	535	949	1552	2091
ΔHeight (in) at Peak				
Ultimate Stress (psf)

Phi (deg)	35.2	Ult. Phi (deg)	
Cohesion (psf)	250	Ult. Cohesion (psf)

Remarks: *DS-CU* A fully undrained condition may not be attained in this test. ΔH is not measured during undrained direct shear tests.

The effective friction angle of a grab sample of sand from a depth of 12 feet to 13 feet in boring B-5 was determined using a direct shear device under consolidated and undrained conditions. The grab sample was sent to Cooper Testing Laboratory, which completed the tests in substantial conformance with ASTM D3080M. Cooper Testing Laboratory used light compactive effort to remold the sample prior to testing. The test results are summarized in Appendix D. A fifth test was attempted at a normal load of 225 pounds per square foot; however, per discussions with Cooper Testing Laboratory, the normal load is below the calibration of their equipment and the data point was discarded.
