PORT DOCK 5 CONCEPTUAL ALTERNATIVES ANALYSIS SUMMARY REPORT
For the
Port Dock 5 Pier Approach – Structural Renovation Design Project
Newport, Oregon
October 11, 2016

OBEC Consulting Engineers

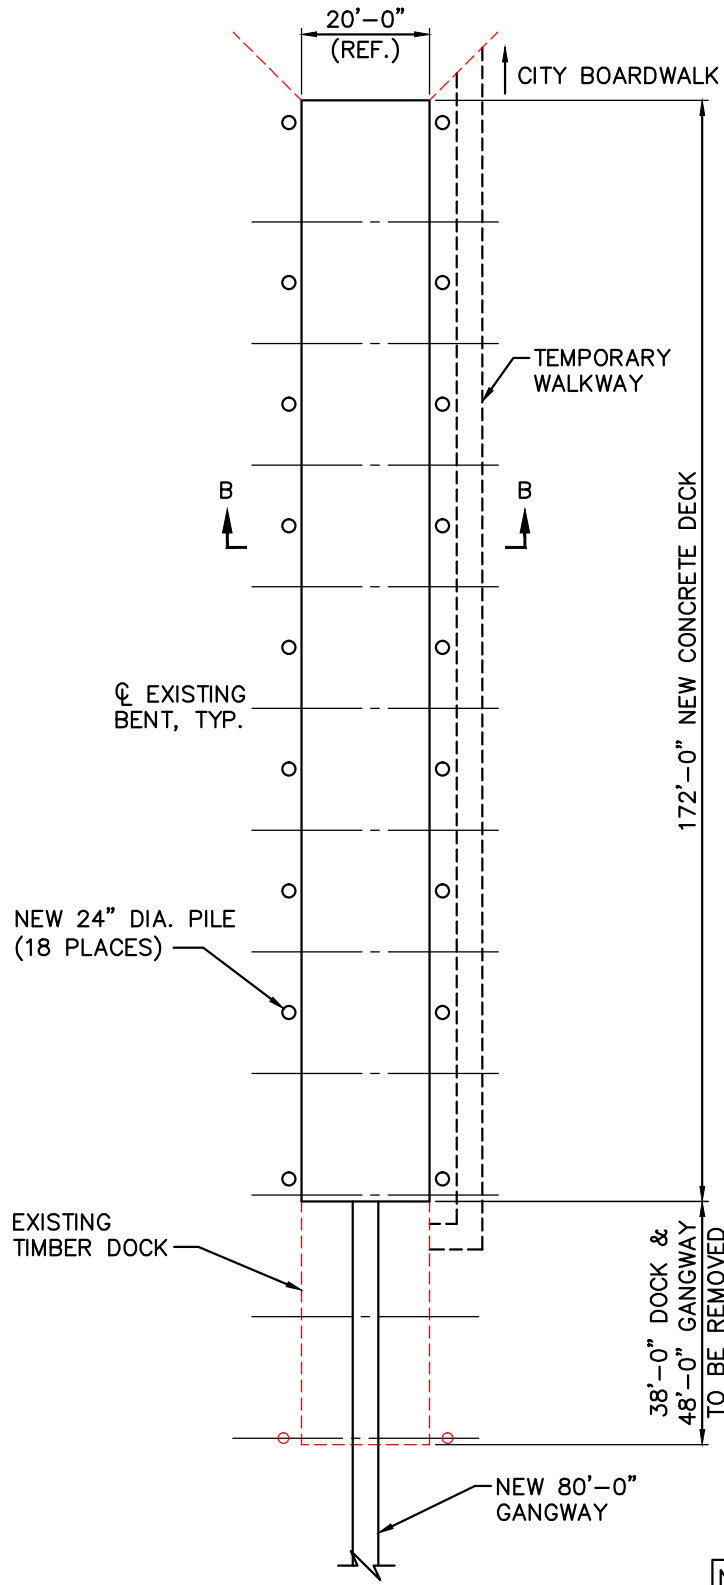
FIGURE 2a

NOTE:
SEE FIGURE 2b
FOR SECTION B-B.

PLAN

PORT OF NEWPORT DOCK 5
 STRUCTURAL RENOVATION
 ALTERNATIVE 2 - PLAN
 DATE: OCTOBER 2016

Summary – This concept proposes to replace the entire fixed dock structure in the same location with steel piles, steel pile caps, and a concrete deck. The dock plan dimensions will not change. Figures 2a and 2b present the plan and section of Alternative 2.
