**Request for Consultant Qualifications
(RFQ # 2022-01)**

**For the
Port of Newport
International Terminal RORO Dock Piling Inspection
and Analysis**

Roll On -Roll Off Dock Piling Inspection

Report Date:
December 6, 2011

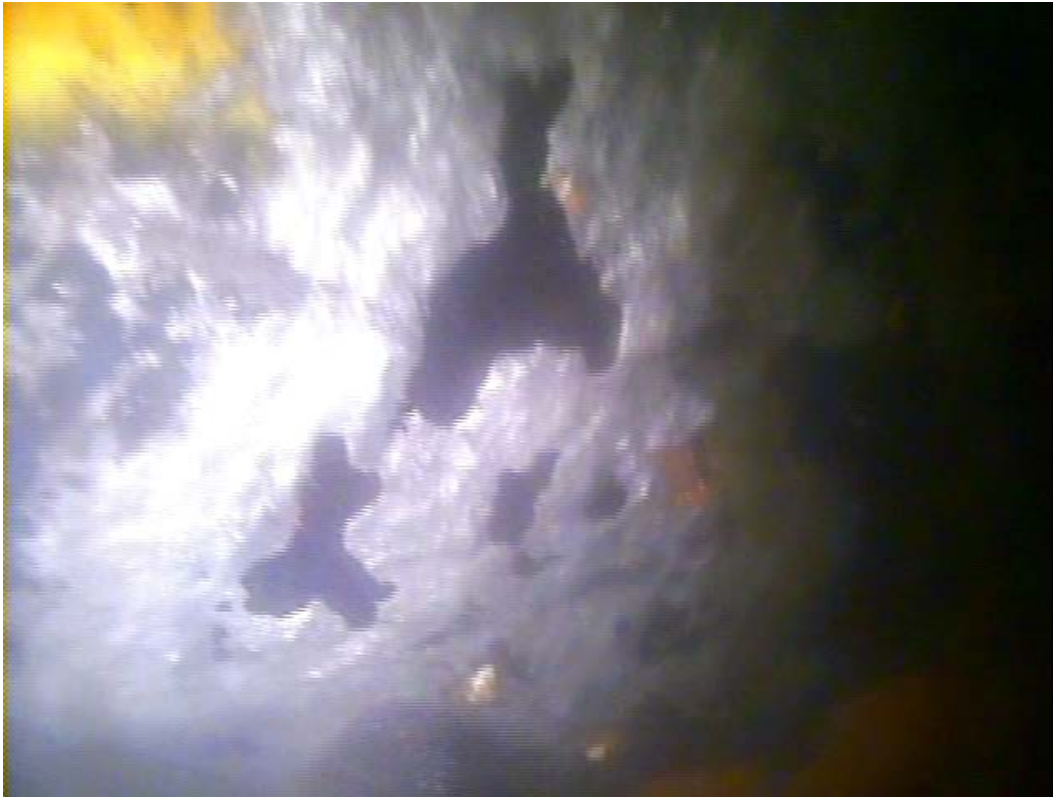
Photo #1: Observed holes in pile G/8

On pile G/8 at approximately 2' above mud line there were holes in the pile in area approximately 8" to 10" long by 4" tall between the South and West sides. These holes were not caused by mechanical damage but more likely from corrosion of the steel. Included with this report are some still photos of this area. We also encountered severe corrosion between the high water mark and the pile caps. This was consistent with all piles inspected.

Based on the observed conditions, Northwest Underwater Construction, LLC recommends that pile G/8 be cleaned of all marine growth and loose corrosion using a mechanical method such as barnacle buster both above and below the damaged area. Further UT readings should be taken and if warranted, a pile repair of the affected area performed.

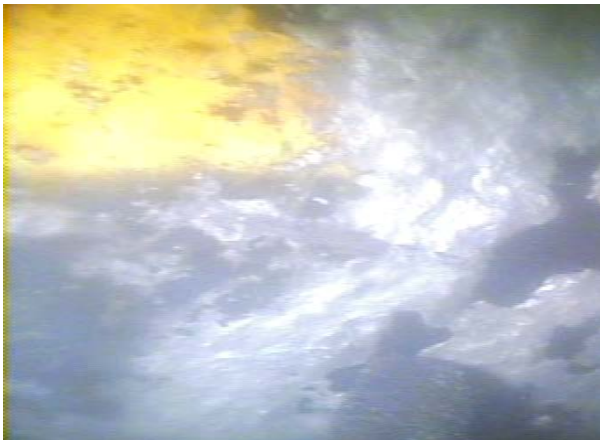
Photo #2: Holes in G/8 with divers finger as a reference
